## Sicherheitsmitteilung 030703

- Datum: 22.07.2003
- Hersteller: Sun Path Produkts, Inc.
- Herstellerbulletin: # SP 02
- Betroffene Systeme : Alle größenverstellbare Javelin- und Javelin Odyssey-Gurtzeuge (meist Schülergurtzeuge).

## Number SP02

**Subject:** MANDATORY INSPECTION

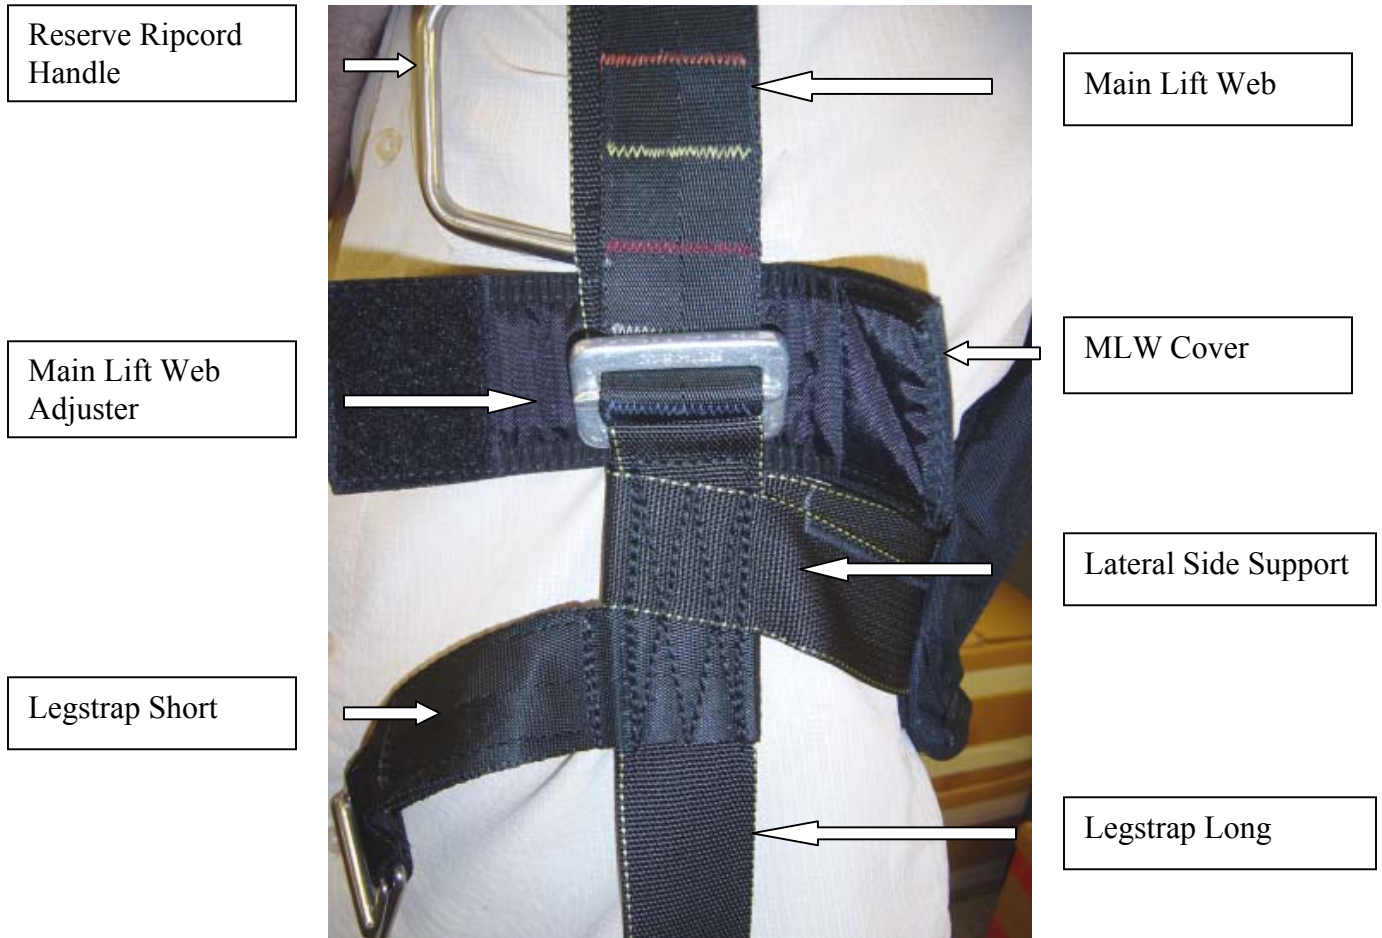
Description of Identification (View shown is “ Wearer’s Left “)

**Identification:** All Adjustable Main Lift Web Harnesses on Javelin and Javelin Odyssey harness/container systems, the majority being Student Systems. The Main Lift Webs (MLW) on the left and right side are threaded through adapters mounted just above the junction of the legstrap and lateral side supports. The Adjusters are primarily used for sizing of the MLW to better fit the user during use.

**Background:** Sun Path Products, Inc. has received notification of a MLW adjuster, used on a Student Javelin harness/container system, shearing through its securing webbing. This failure may or may not have resulted in a fatality.

**Inspection Requirement:** The webbing securing the adjuster in place at the junction of the legstrap and lateral side supports is to be inspected for wear and tear. If the webbing shows signs of fraying or abrasion that is inconsistent or appears to be excessive with what would be termed “normal wear”, the harness/container system is to be grounded and Sun Path Products, Inc. is to be contacted for further action
