ÖSTERREICHISCHER AERO-CLUB

Sicherheitsmitteilung 040902

Herstellerbulletin: N°04/002 von 23/08/04

Betrifft: Umlenkklappe (Deflector flap)

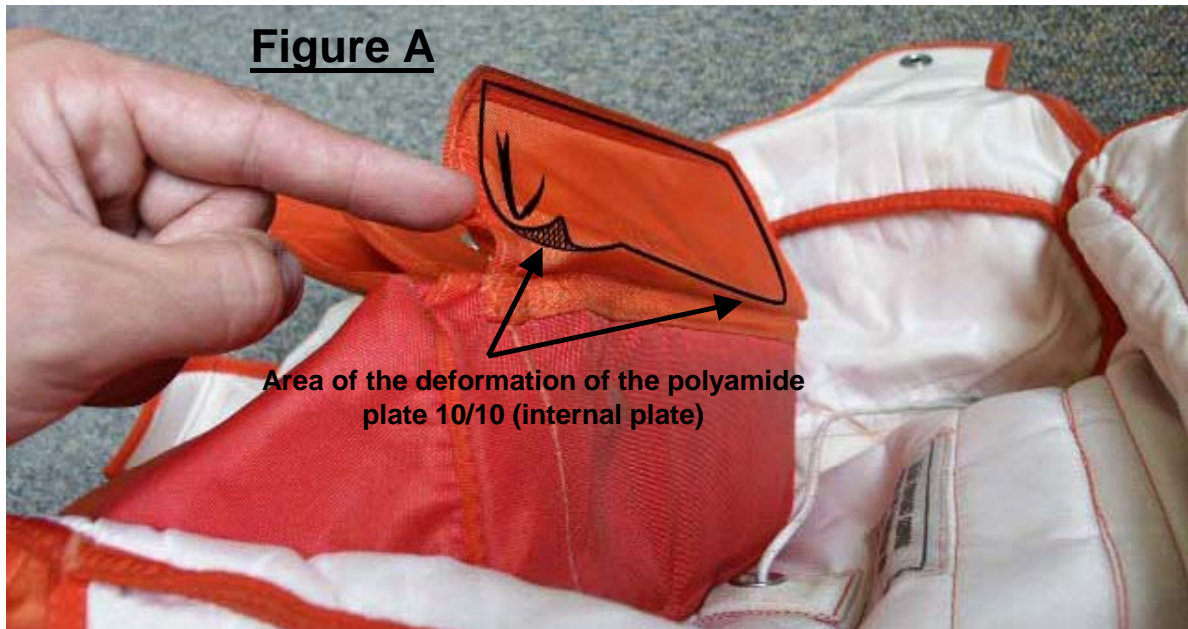
A deformation of the polyamide plate 10/10 (internal plate) of the deflector flap may occur near the sewing that binds the deflector flap to the container (see figure A).

Depending on the way the deflector flap is placed on the main deployment bag during the packing process, it may be deformed in time and its efficiency may be reduced.

Case N°1 : In the event of a deformation as shown on figure A : Before using the equipment again, get a qualified rigger to make a sewing on the deflector flap as shown on figure B.
