Sicherheitsmitteilung
SM041202

Datum: 15.12.2004

Betrifft: Metalltrenngriff für Atom Tandem /MMS

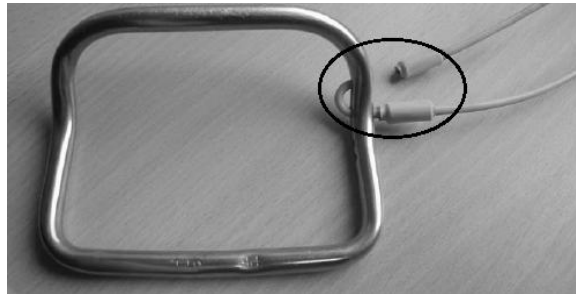
Maßnahme: Bei einem Metalltrenngriff (P1010167600) brach das gelbe Kabel an der Stelle, an der es durch die Bohrung im Griff lief. Der betroffene Griff war 11 Jahre alt und wird seit 1998 nicht mehr erzeugt. Vor dem nächsten Sprung Überprüfung, ob das Kabel beschädigt ist. Jeder Griff, bei dem auch nur der geringste Schaden festzustellen ist, ist zu ersetzen.

Bemerkung: Alle angeführten Griffe, auch solche ohne sichtbare Beschädigung, sollten sofort ersetzt werden, spätestens jedoch bei der nächsten Jahreszulassung.

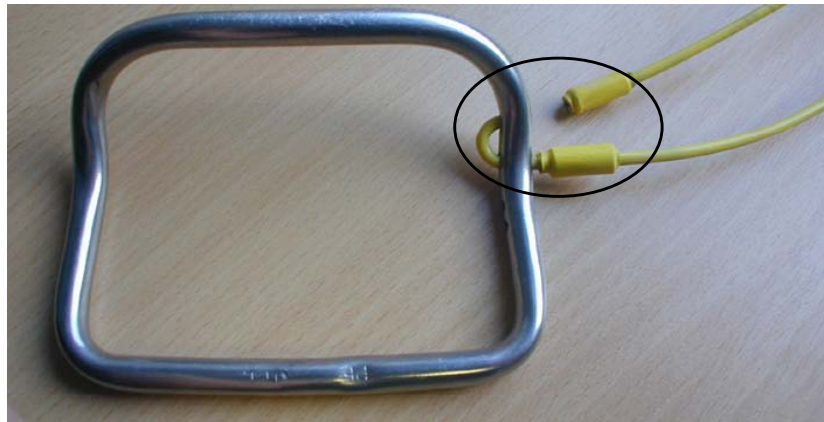
A user reported the breaking of one of the coated cables of a MMS metal cutaway handle for main canopy (ref P1010167600). The breaking occurred at the contact point between the coated cable and the upper drilling of the metal handle. The affected handle is 11 years old, this model has been discontinued since 1998.

The repetitive bendings of the metal part of the cables, at their contact point with the metal handle, have caused the ageing and the weakening of the cable resistance. The metal cutaway handles for Atom Tandem (ref P201016700), which are identical to the MMS metal cutaway handles, are bound to be affected.

1. To be done RIGHT NOW : Inspect the cables at their contact point with the handle. Replace any handle the cables of which would show signs of breaking.
2. To be done AS SOON AS POSSIBLE : Replace all the handles even though the cables do not show any signs of breaking.
