**Regarding
Performance Designs Service Bulletin # 002
Relative Workshop Service Bulletin # 230505.**

SERVICE BULLETIN

Date: 5/23/2005
Service Bulletin #: PDSBLTN-002, RWSBLTN-230505
Subject: Inspection of Tandem VTC-III reserves (VR-360) A Line Attachments and Steering Lines.
Status: MANDATORY

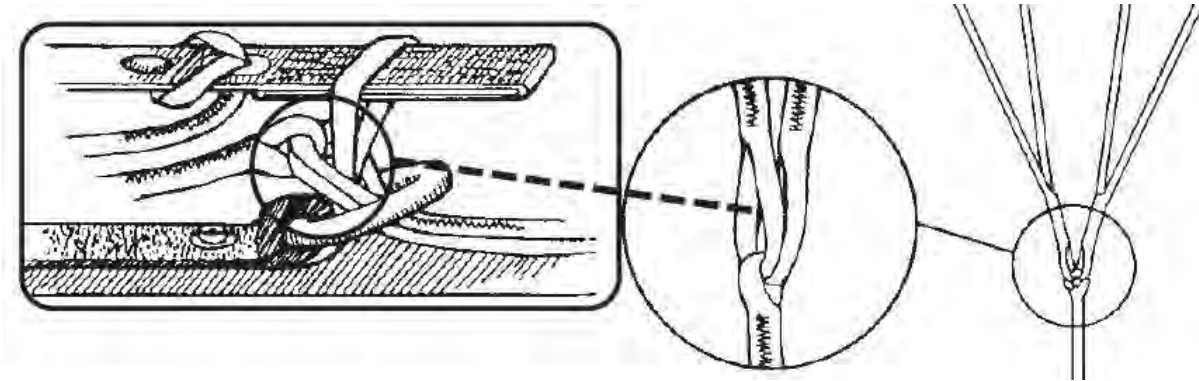
Correct Brake Setting

Some VR-360's were manufactured with the lower control line loop to be as large as the upper control line loop at the cascade. While there is no impact to the structural integrity, or performance of the canopy, this situation opens the possibility for the riser brake-setting loop to be misrouted through the lower control line instead of the correct location in the upper control line as shown below. Improperly set brakes can result in brake line failure during opening and unusually high opening forces.

1. Inspect the LST attachment loop per the attached Inspection Procedures Section 2, LST Loop Inspection.
2. If either steering line does not comply with the proper configuration of the loop, the parachute must be brought into compliance by a certificated rigger following the provided instructions prior to placing back in service.

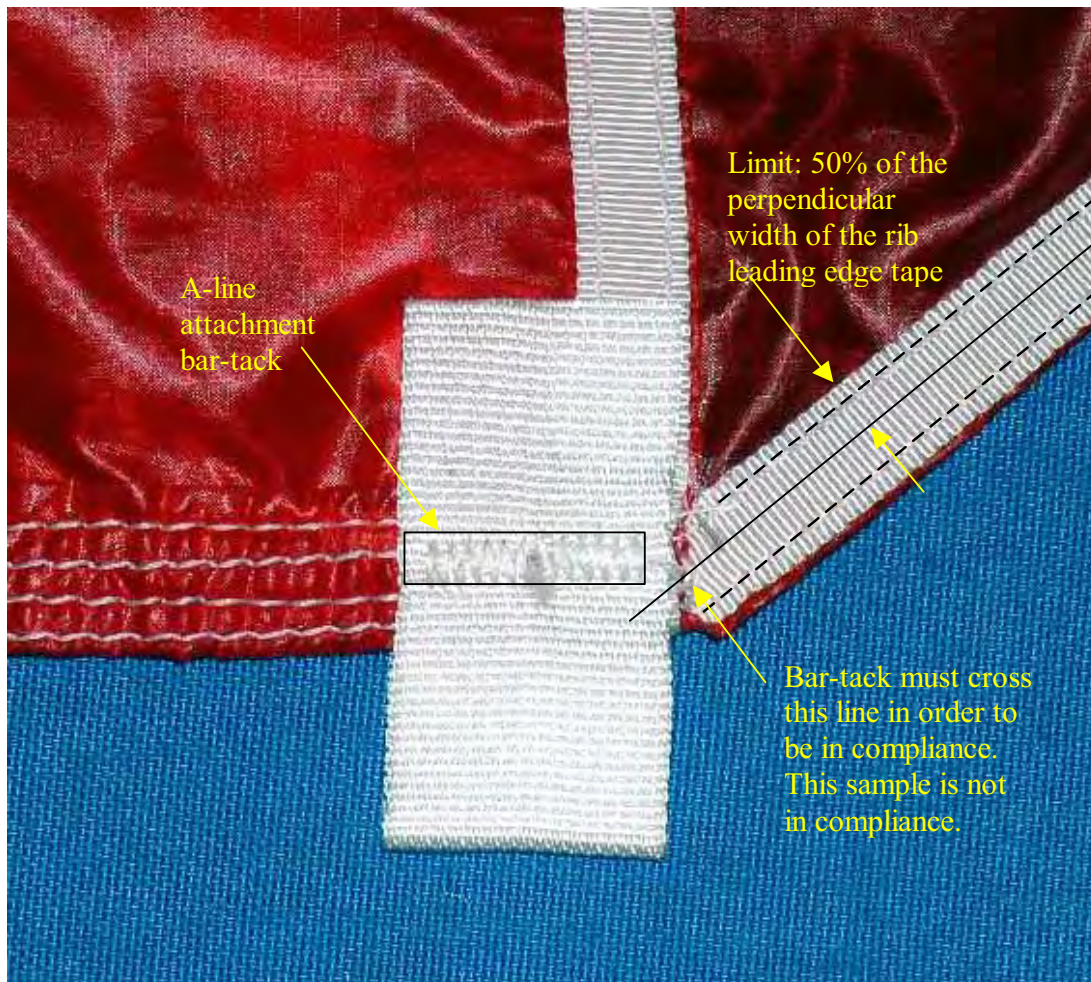
Figure 1 Rib leading Edge Tape Inspection

The A-line attachment bar-tack must be sewn through at least 50% of the width of the loaded-rib leading edge tape.

- Using a ruler, find the centerline of the rib-leading edge tape. This may be lightly marked with pencil if necessary.
- Using the ruler, extend the centerline of the leading edge tape to the vicinity of the bar-tack.
- Observe the location of the bar-tack with respect to the tape centerline.

1. Inspect all ten of the A-line attachments per the attached Inspection Procedures, Section 1, A-line Attachment Inspection Procedure.
2. If any of the 10 A-line tab bartacks do not comply with the proper alignment the parachute must be brought into compliance by an approved service facility. Adjusting the line tab requires a specialized heavy-duty bartacker not commonly found in the field.

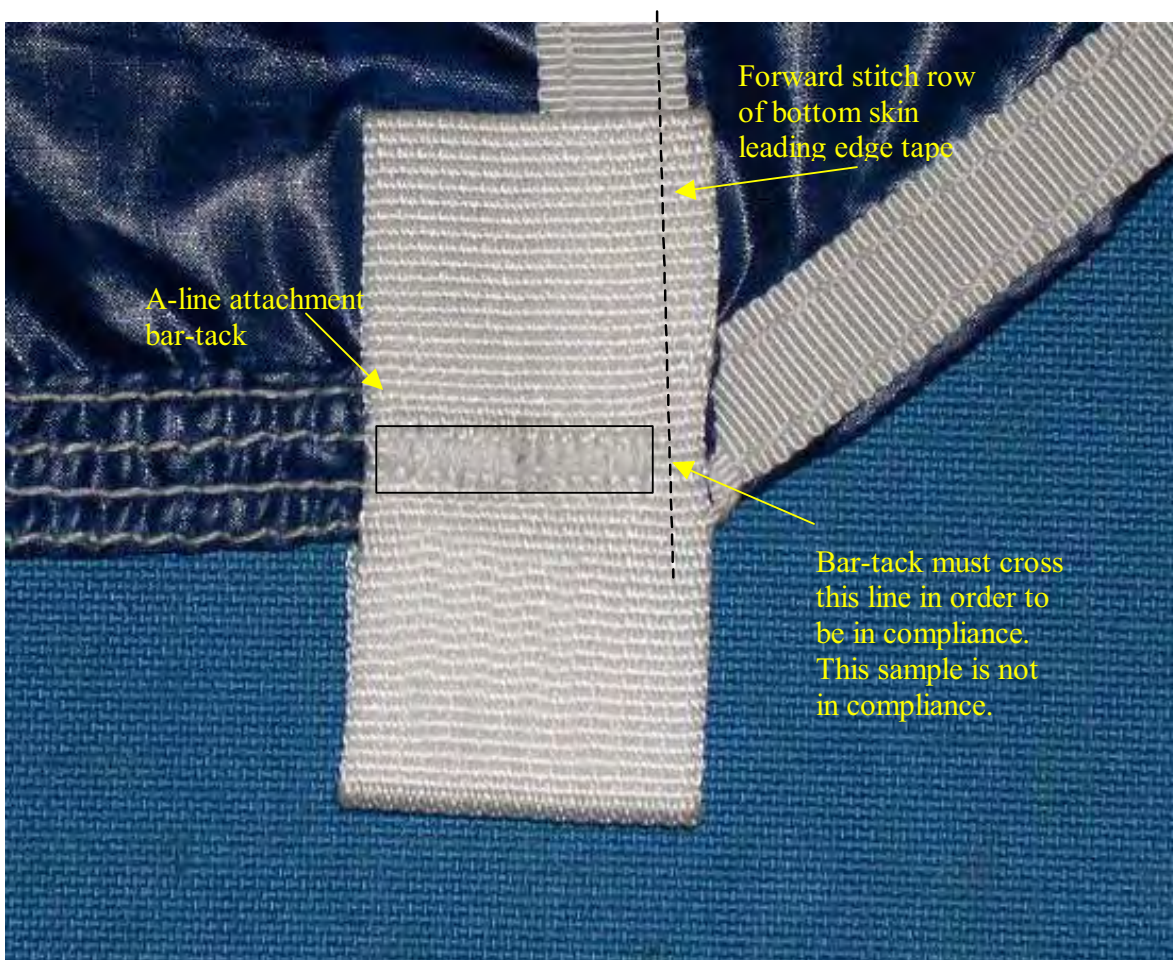
Figure 2- Bottom Skin LE Tape Inspection

The A-line attachment bar-tack stitching must extend forward of the forward stitch line on all the bottom skin leading edge tapes. Inspect both sides of tab.

- a) Locate the forward stitch row of the bottom-skin leading edge tape.
- b) Using a straight edge, extend the forward stitch line of the leading edge tape to the vicinity of the bar-tack.
- c) Observe the location of the bar-tack with respect to the tape stitch row. The bar-tack may or may not overlap the edge of the line-tab, but it must cross the stitch-row and be going through the tab at this point.

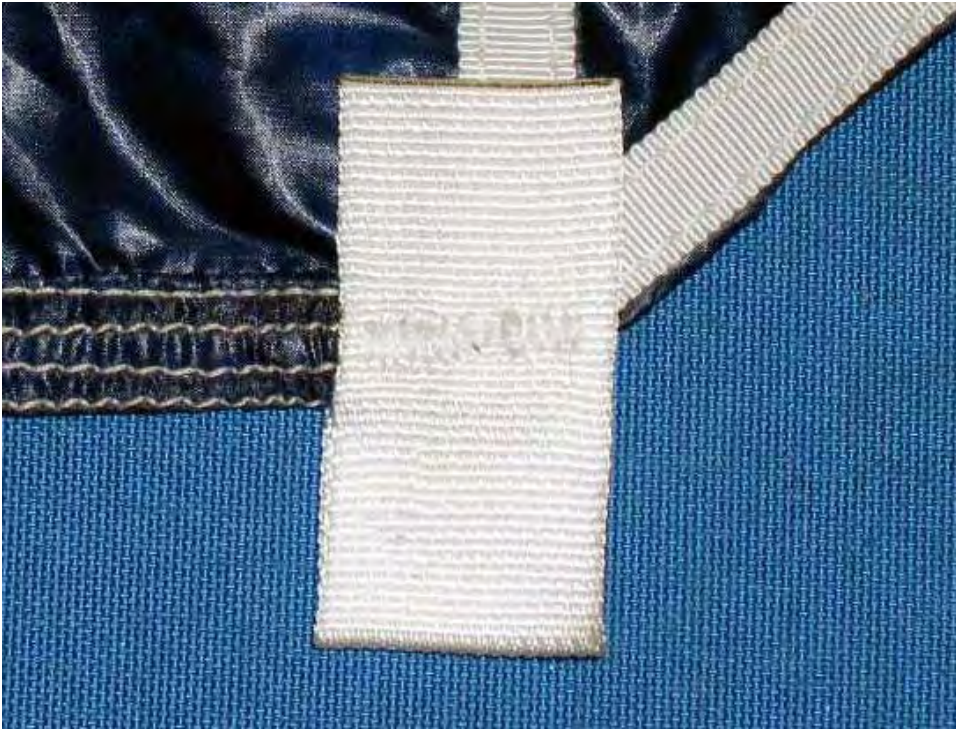
Figure 3 Acceptable Line Attachment Bar Tack

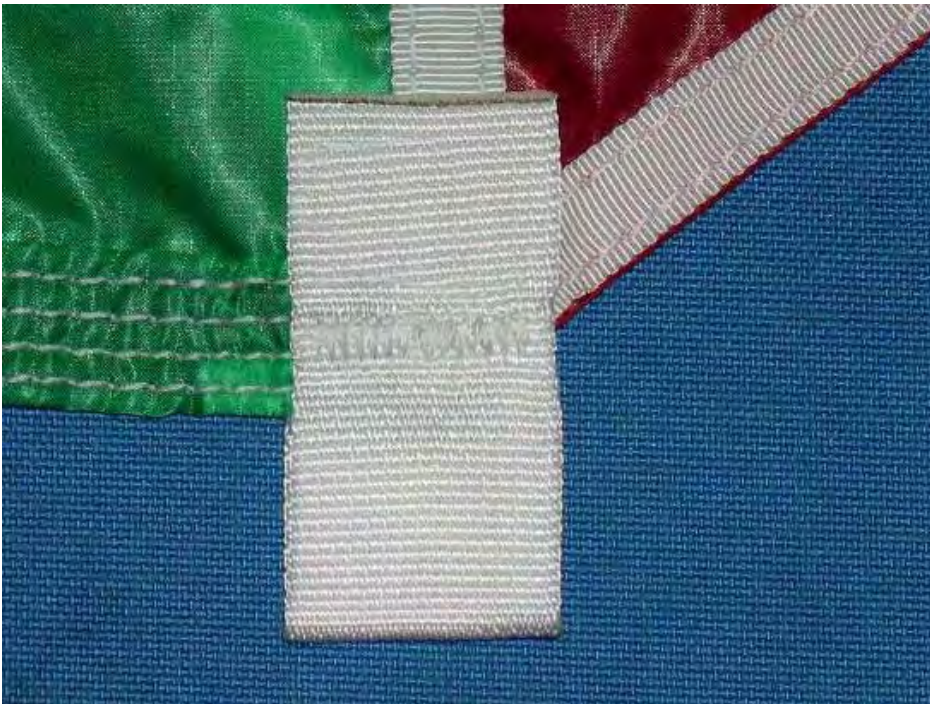
Figure 4 Acceptable Line Attachment Bar Tack

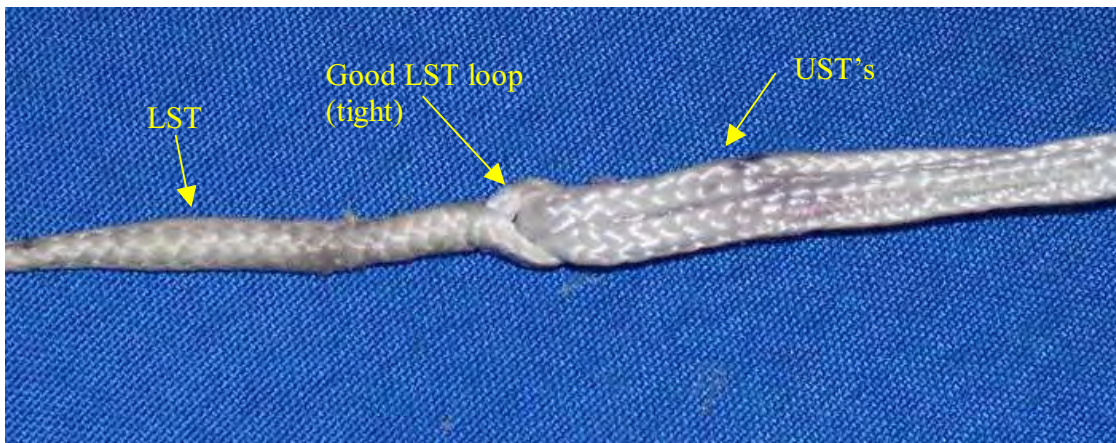
Check each of the LST's (lower steering lines, the line that passes through the toggles) where it loops around the UST (upper steering line). This loop must be small enough that the brake setting loop on the risers cannot be pulled through.

Figure 5 Good LST Loop

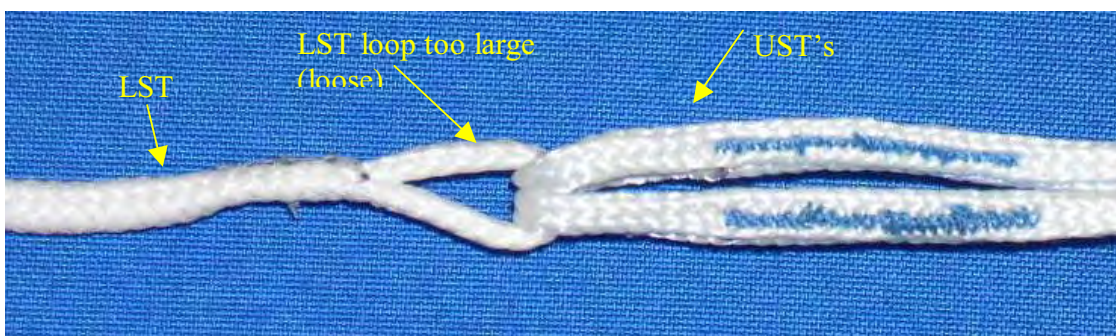
Figure 6 - LST Loop too large

The LST loop may be reduced to an acceptable level by adding a bar-tack or zigzag stitch to reduce the open legs of the loop. The following includes directions for reducing the existing LST loop.
