Sicherheitsmitteilung SM051102

Herstellerbulletins. N°050801 von 16/08/2005 und Addendum
S.B. n° 051101 von 3/11/05

Betreff: ADVANCE – Gurtzeuge
Gebrochene Naht vom Brustgurt und zu lose Hand-Deploy Tasche.

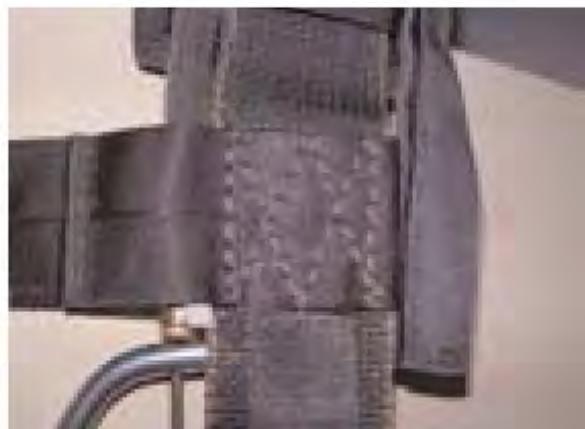
Old conception

Maßnahme: Bei allen Systemen ist verpflichtend die Hand-Deploy Tasche zu überprüfen.
Zu lose oder beschädigte Taschen müssen erneuert werden
Bei allen Systemen mit Typ8 Brustgurt:

muss dieser in die neuere Umwicklungskonstruktion geändert werden.
Neuer Brustgurt:

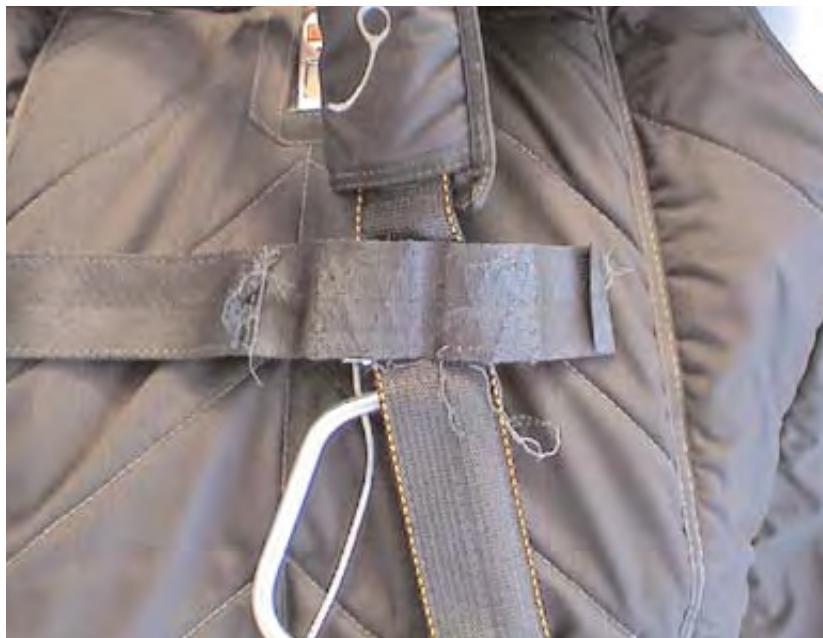
After eyesight some photos that we've recovered (we haven't still the equipment to disposal),the main pilot chute inflated on the right side and a very hard opening happened while the student was in the head down position left slice side. This hard opening has provoking the stiches failure of the chest strap and of some secondary stiches as well.

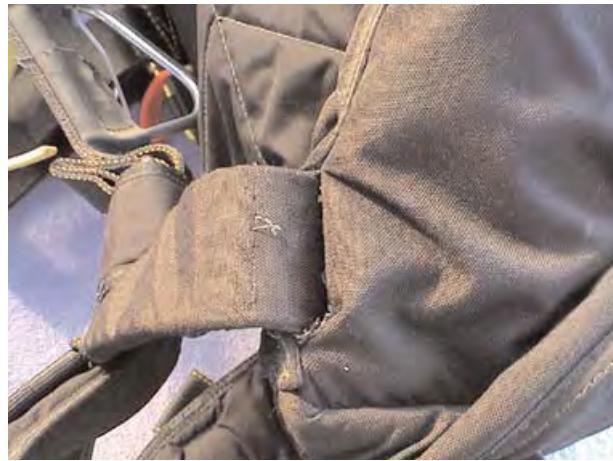
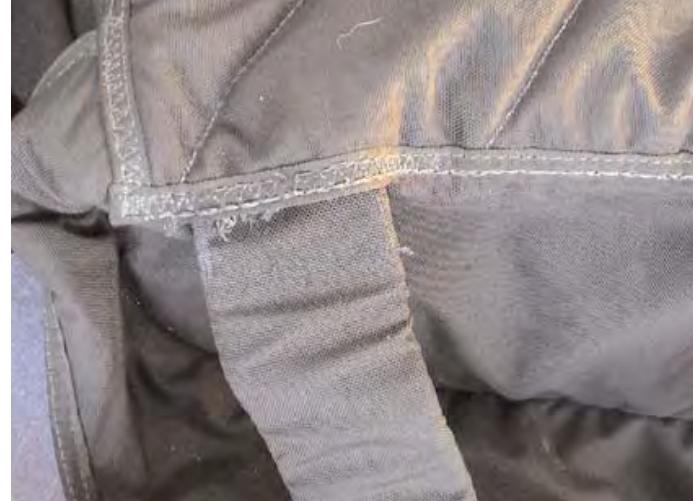
Container junction with the lateral webbing as been slightly damaged too.

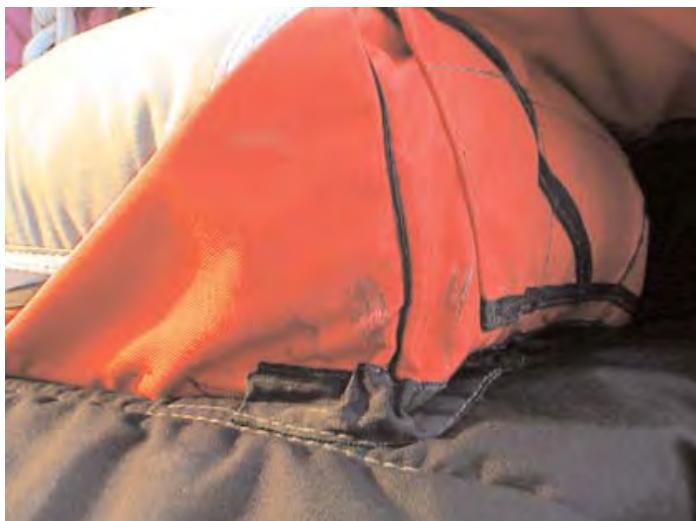
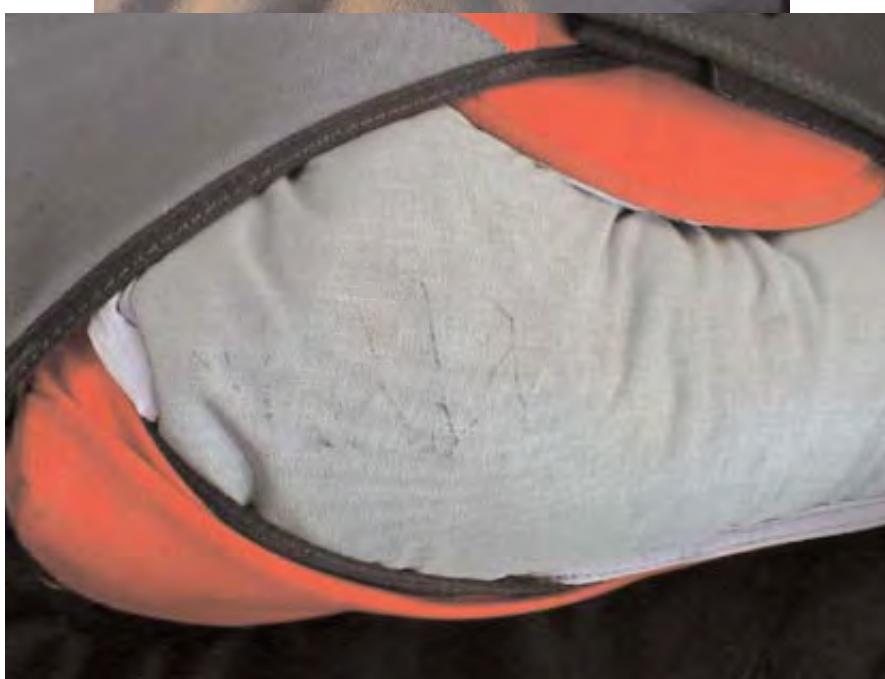
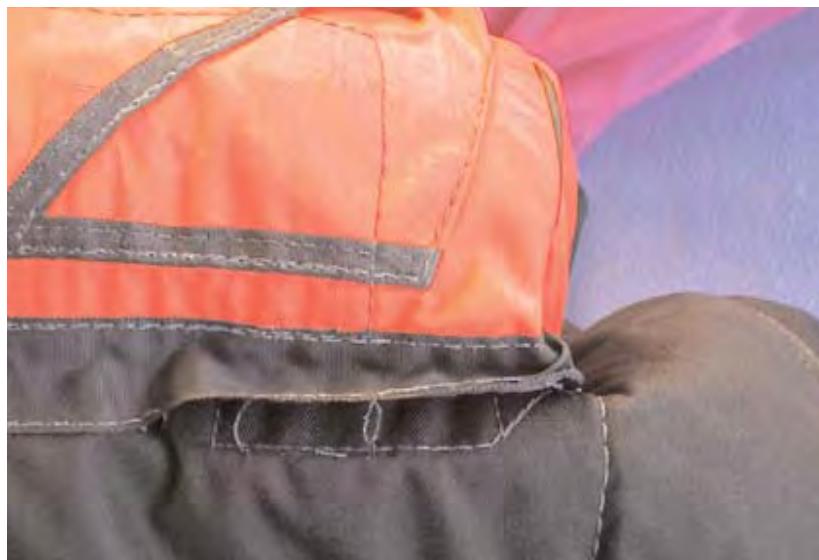
Several burns done by the main canopy lines and risers are on the reserve container divider flap and on the reserve bag as well.

Stiches from the reserve container reinforcement tape are damaged too.

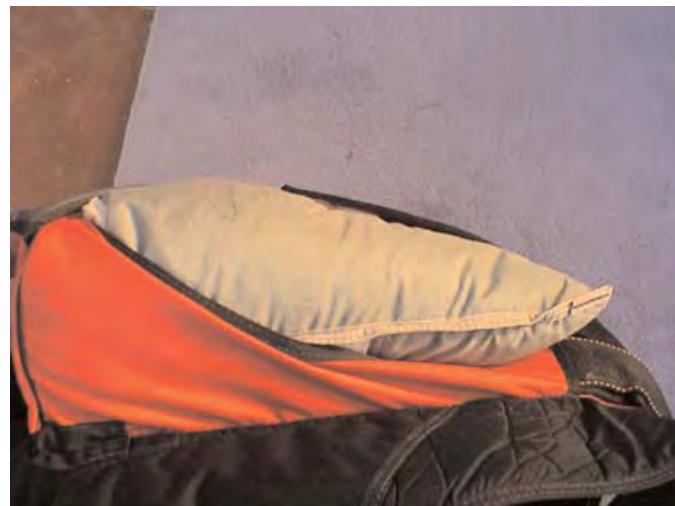
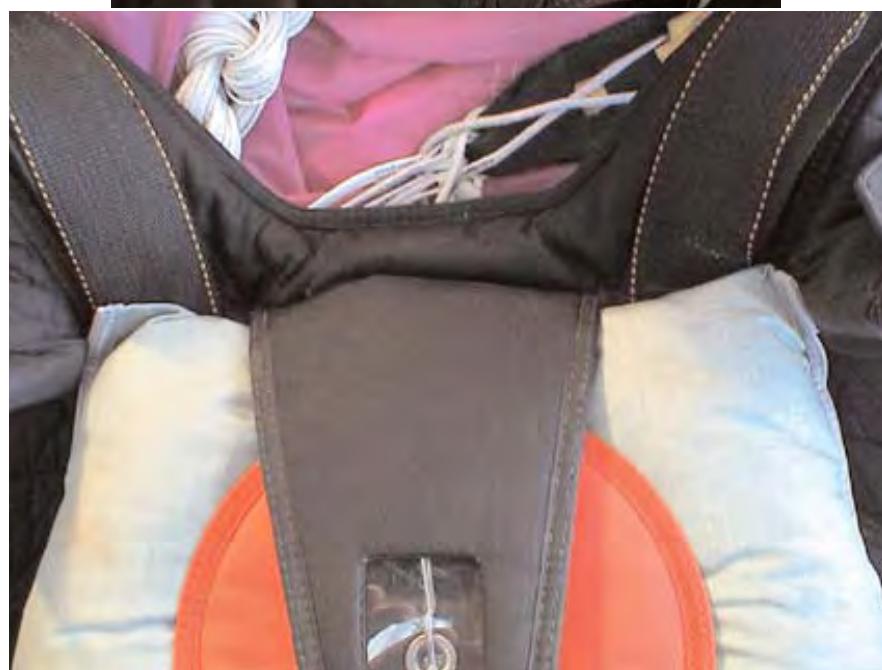
Because of the important stress the reserve bag has been push downward the bottom of the reserve container. The reserve pin stayed secured. This shown how big the forces transfer has been developed.

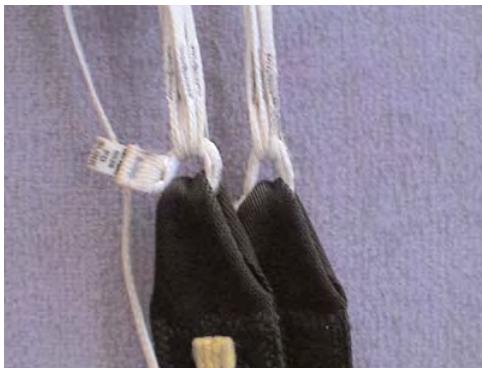
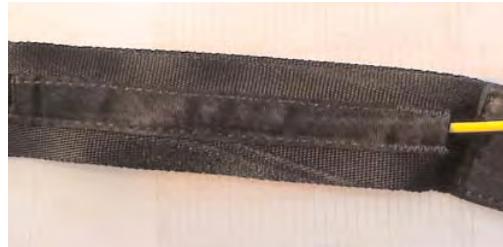
Left main riser grommet has been a bit damaged (no picture) and a burn can be seen on it. The riser lengthen up to 1 cm.

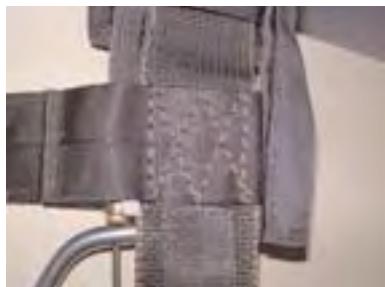
Old conception

We have seen that the method of conception of the chest strap can be made in a better way. This method will avoid any fall of the user from the harness in such situation. We are suggesting to make a complete confluent wrap with the chest strap webbing around the left main webbing. (right picture) instead having just a part of the webbing around it (left picture). By this way in case of seams failure the chest strap webbing will remain to protect the user of any falling possibility. Elasticity differences between type 7 and type 8 webbing and this type of conception used are not the best method in such dissymmetrical stress and hard opening. Seams cannot resist in such situation because stiches cannot be as elastic as the webbing is.

It is evident that this kind of separation of the chest strap from the main lift webbing can happen to any kind of conception which doesn't integrate a complete confluent wrap around the MLW. The conception we used and those who consist to insert the chest strap between the MLW (even if it is stronger) do not protect at all the user from a falling possibility from its harness in case of such violent opening and stress transfer to the chest strap.

We are asking to have all Advance harness-container equiped with a type 8 chest strap which not used a confluent wrap to be return for modification to our factory. This modification can also be done into a certified rigging loft. This modification is mandatory and it is totally free of charge for the customer.
