ÖSTERREICHISCHER AERO-CLUB

Sicherheitsmitteilung

060102

Änderungen Packanweisung

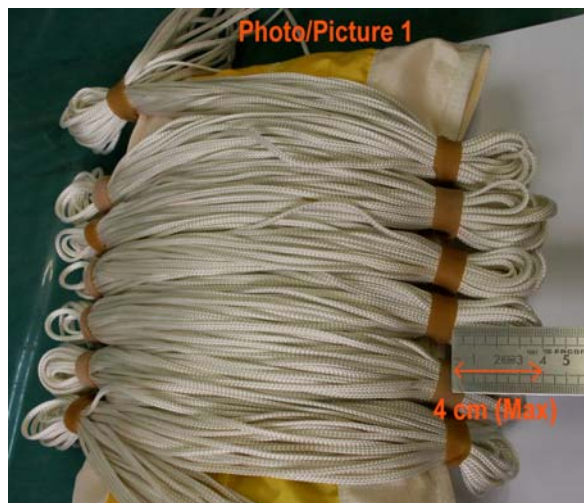
The damages are due to one or more overlies causing the damage of several panels. It is likely that this incident is due to one or more lines passing over the diaper during the extraction of the container.

- if there is too much lines not stowed on the diaper,
- if the stows are too long.

- The length of each stow should not exceed 4cm. **Cf Picture 1**,
- The packer will have to limit the length of lines not stowed (between the last stow and the links on the risers) by adding rubber bands if necessary,
- The length of lines between the last stow, and the links on the risers should be 25 cm as a maximum **Cf Picture 2**,
- The packing with diaper on the top of the container is cancelled. The only possibility is now to put the diaper at the bottom of the container **Cf Picture 3**.

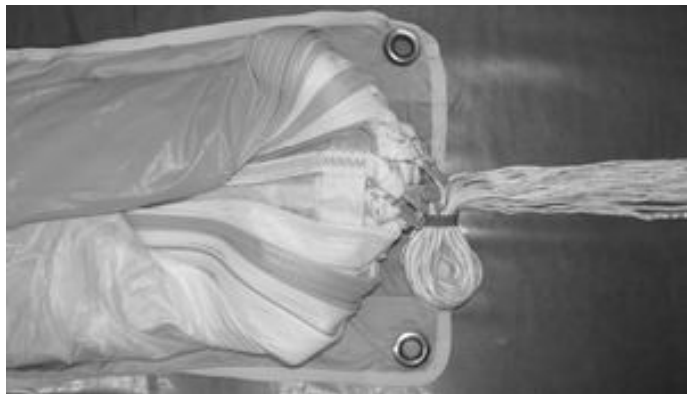
PICTURE 1

The damages are due to one or more overlines causing the damage of several panels. It is likely that this incident is due to one or more lines passing over the diaper during the extraction of the container.

- To replace the current rubberbands by **mini rubberbands optima P/N 2015000600** (Cf picture 2).
- To use an additional mini rubberband optima on attachment tapes number 11 (diaper line) in order to add an additional stow at the beginning of the stowage (Cf picture 1).
