## ÖSTERREICHISCHER AERO-CLUB

### Sicherheitsmitteilung

SM 060401

**Betrifft:** Beschädigungen an der Plastikhülse des Cutters und am Loop

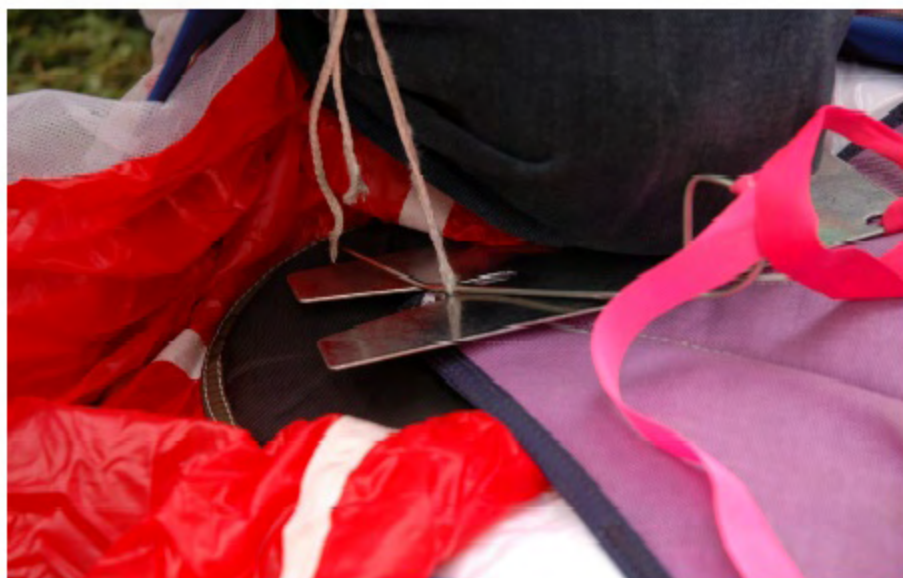
#1

We would like to remind you that it is not allowed to use inadequate mechanical tools (force reduction systems) to close the reserve parachute. Those mechanical systems could implement a too important traction effort (above 10 daN maximum according to the TSO norms) to release the pin of the reserve parachute (see pictures #1, 2& 3 of Russian + South American + European Tools).

A particular attention is requested to look carefully that the small plastic loop protection heads of the cutter(s) are not damaged during the repack of the reserve. If any degradation sign is detected on the plastic loop protectors, it is imperative to replace the cutter unit and the loop to avoid any reserve loop deterioration.

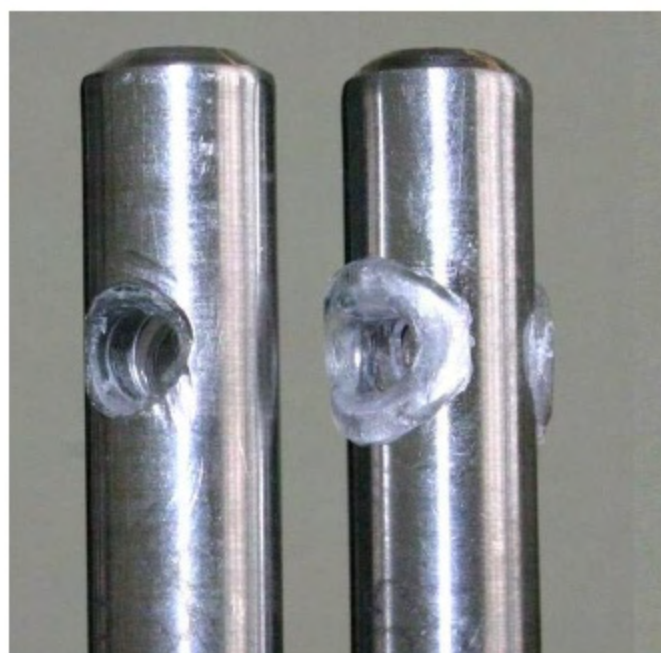
#4

The use of an inadequate mechanical system or the wrong placement of a temporary pin can cause the crushing of the cutter against the grommets or the temporary pin during the closing of the reserve (for example: using a temporary pin placed above the pilot chute, then placing the flap with the cutter and start traction on the closing loop with the temporary pin still in place). Those closing techniques could create such forces that the pressure between metallic grommets or pin could damage the plastic protection ring as even the stainless steel cutter body (see picture # 4).

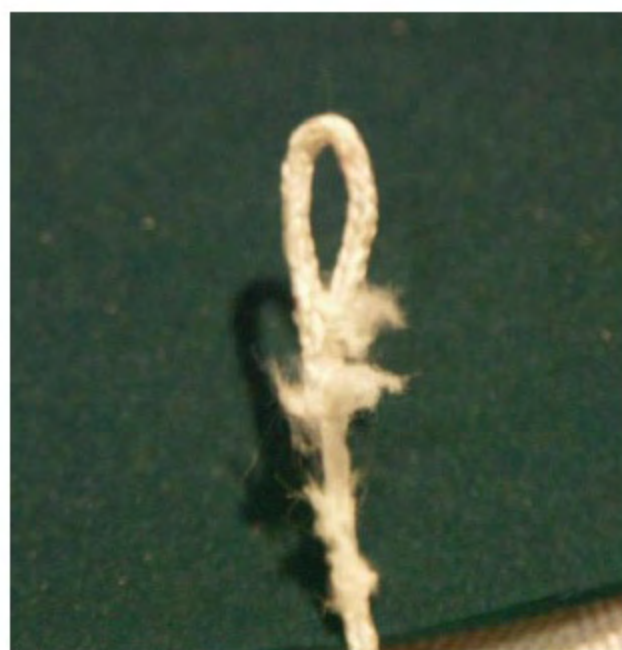
#5

Any damage of these plastic heads could provoke a deterioration of the reserve closing loop by friction during transport or use of the equipment. Those deteriorations could cause an inopportune opening of the reserve container (see picture #5).
