SERVICE BULLETIN SPSB005
JH101-3 (HIP RING MLW) AND JH101-4 (4 RING MLW) RING DAMAGE
INSPECTION

SERVICE BULLETIN # SPSB005

SUBJECT: HIP RING AND 4 RING MAIN LIFT WEB INSPECTIONS

STATUS: MANDATORY

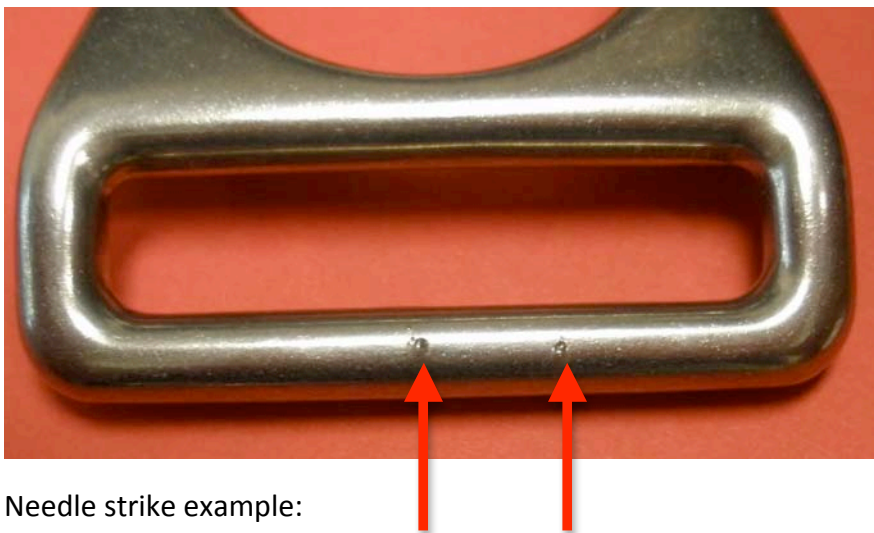
Needle strike example:

It has been brought to our attention that the hip ring on JH101-3 (Hip Ring Only) and JH101-4, (4-Ring) main lift webs, may have been struck by the needle used for installing the 5 cord harness stitching. This needle strike on the hip ring may cause damage to the Type 12 buffer, 5 cord stitching and possibly the Type 7 webbing. As a precaution, a mandatory inspection of the hip rings is required for all systems with a date of manufacture between September 2008 and December 2008.

The picture below is an example of a needle strike on an SR8 hip ring.

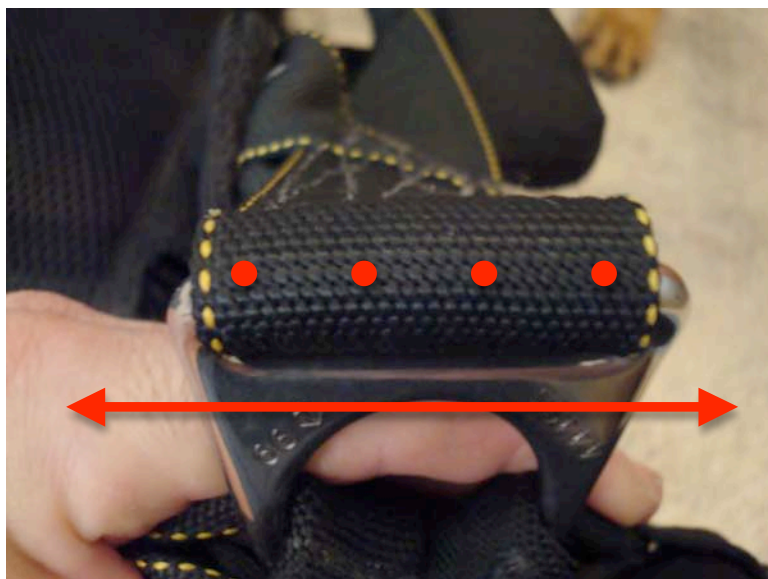
6. Move the hip ring back and forth (side to side) and rotate inside the webbing, while pressing the top of the ring through the webbing. If a needle strike is present, the rough spot on the top of the webbing bar of the ring will catch or snag on the TYPE 12 buffer on the inside of the TYPE 7 MLW. This will feel like a rough spot(s) on the top of the bar and cause a rough or snagging feel.

FEEL HERE FOR DAMAGED RING INSIDE WEBBING. DAMAGE WILL MOST LIKELY BE ALIGNED WITH THE BOTTOM POINTS OF THE 4 POINT STITCH PATTERN.

1. If damage is found or suspected, the harness/container will need to be sent to Sun Path Products, Inc. for repair. Please ship to the following address and include a completed Hip Ring Damage Repair Form found at the end of this document:

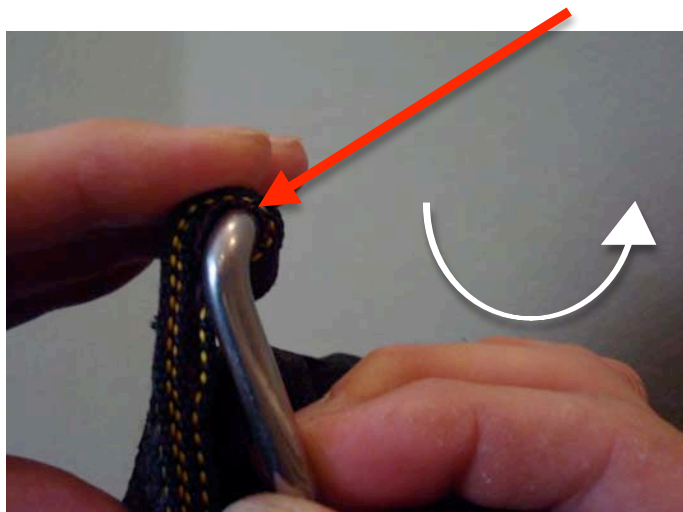
WHILE ROTATING, FEEL HERE FOR NEEDLE STRIKE.
