Sicherheitsmitteilung SM 130101

Betrifft: ICON Gurtzeuge / Launch des ICON Reserve-Pilotchutes

Icon Reserve Pilot Chute Failed to Clear Side Flaps, Ser #IN-I5-12509, DOM Sep 2008

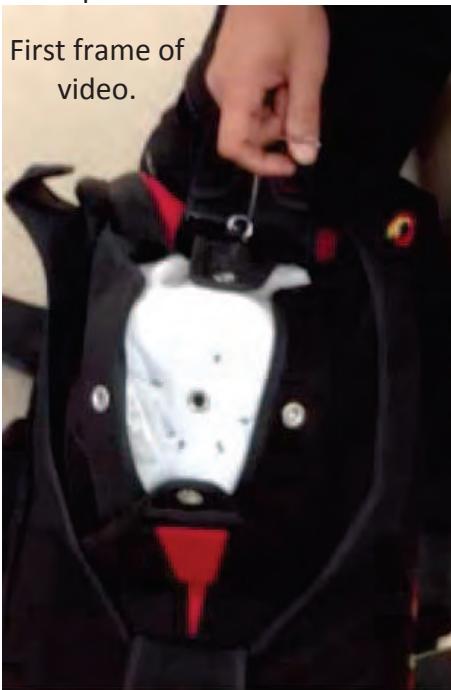
19 November 2012 it was reported that when the pin was pulled for routine repack, the reserve pilot chute failed to clear the side flaps and a video was provided as shown in the captures below.

First frame of video.

It was noted from the provided video that the rig was not being worn and the pin was not pulled by its handle. The video shows that it was sitting on the ground and appears to have been pulled by the cable close to the pin, this would mean that this rigger's hand had to have contacted the #5 flap once the pin was clear of the loop interfering with its normal activation.

Riggers in the field should note that when opening a reserve for its scheduled repack that all manufacturers advise that it should be worn on the shoulders and actuation initiated by ripcord handle.

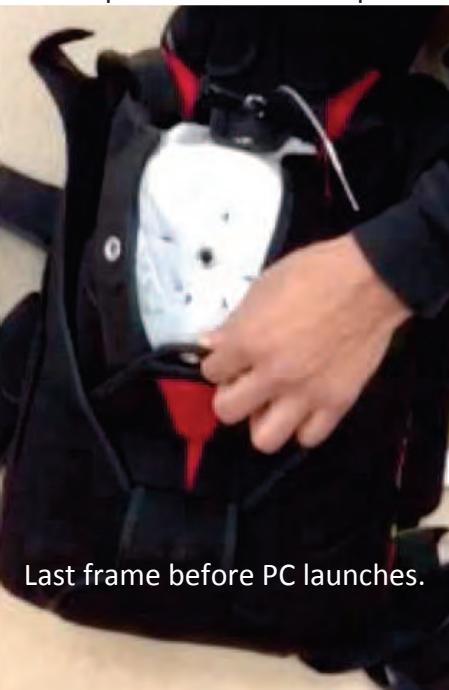
Last frame before PC launches.

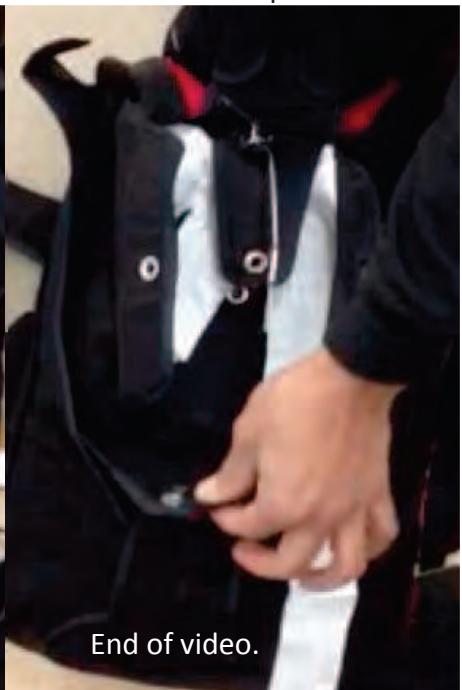
End of video.

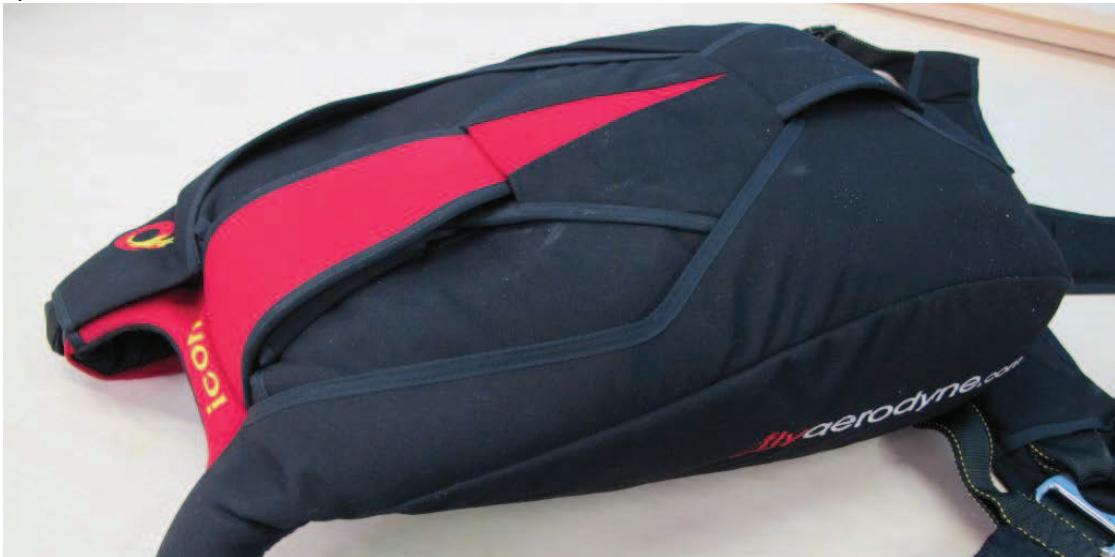
The rig arrived 29 November 2012 with the reserve closed as shown below and the first observation was that the loop was on the excessively long side and the reserve PC was not at full compression.

When the loop is excessively long and the reserve pilot chute can be compressed some after closing, it has lost a good part of its energy and has a big effect on its performance.

- 1) darauf achten, dass der Reserveloop nicht zu lang ist (der Reservepilotchute darf sich am geschlossenen System nicht mehr weiter komprimieren lassen)
- 2) der Hersteller empfiehlt bei der Routineöffnung zum Repack das System über den Schultern zu tragen (wie beim Sprung) und über den Reservegriff zu öffnen

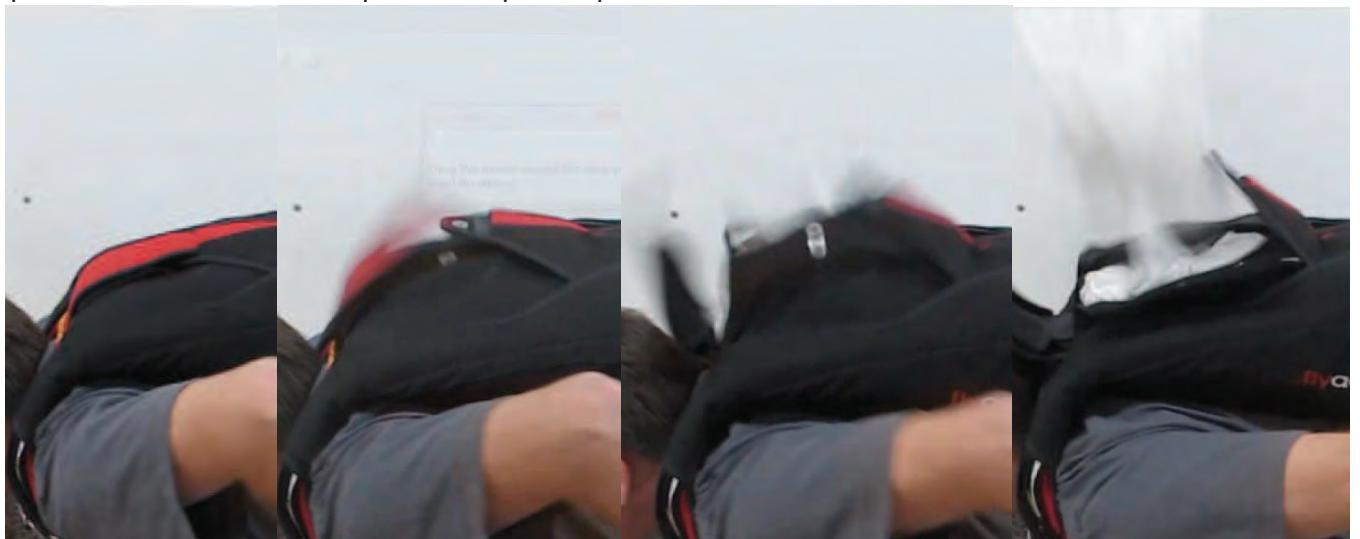
The rig was then test pulled exactly as it arrived. A good launch with no hesitation was observed. See captured video below. Video provided upon request.

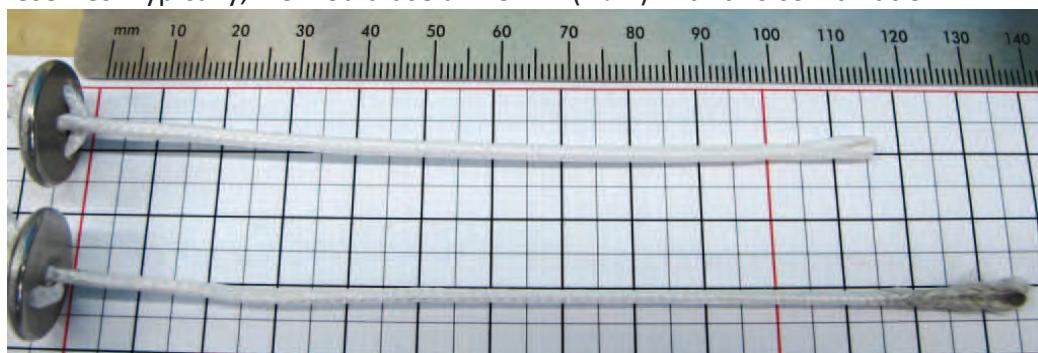
After opening, the loop measured to be 137mm (5 $\frac{3}{8}$ "), this is common length used here on tandem reserves. Typically, we would use a 115mm (4 $\frac{1}{2}$ ") with this combination.

←Actual loop taken
from I5 #IN-I5-12509.
