## ÖSTERREICHISCHER AERO-CLUB

### Sicherheitsmitteilung SM161001

**Bezug:** SERVICE BULLETIN 02/09/2016 der Herstellers MarS a.s.

**Betroffene Muster:** m2AAD

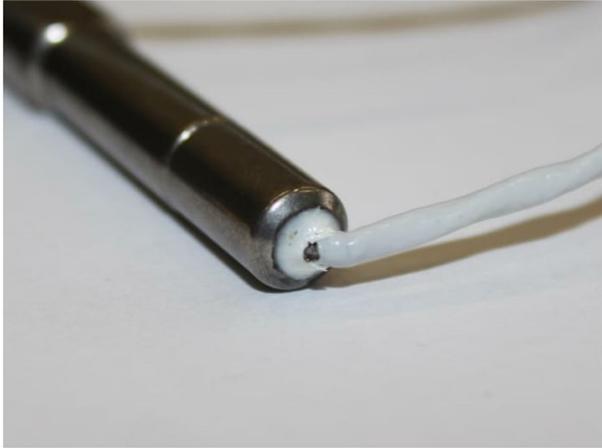
</div> <p style="text-align: right;">Fig.1</p>

**Grund:** Kabelbruch, Risse in der Verbindung Cutter-zu-Kabel, Risse in der Isolierung.

a. If a problem exists with the cutter this will be detected by the control unit and displayed as an error No.2. In this case, the cutter must be replaced immediately.

b. If no error is detected, then the AAD may remain in use until the next repack cycle. During the next regular repack the cutter must be inspected and replaced if it is affected by this bulletin.

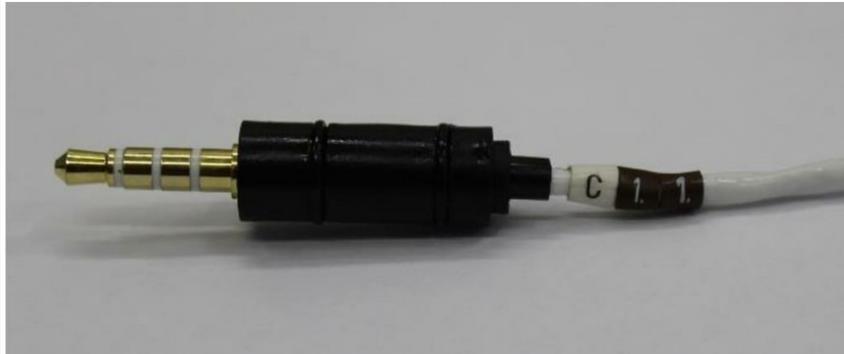
Fig. 2 Series C, year 2011 (marked on cutting unit cable)

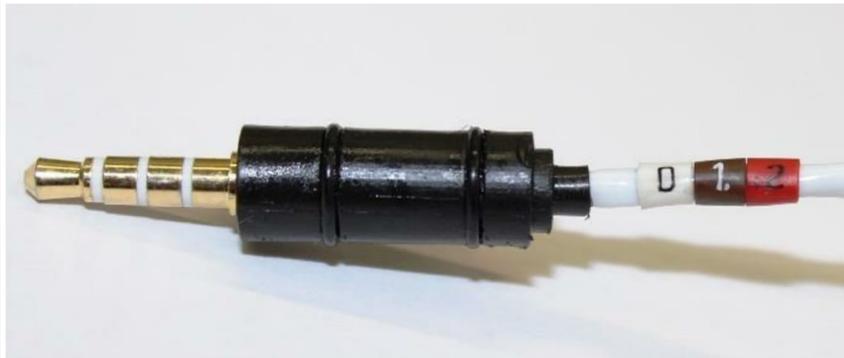
Fig. 3 Series D, year 2012 (marked on cutting unit cable)

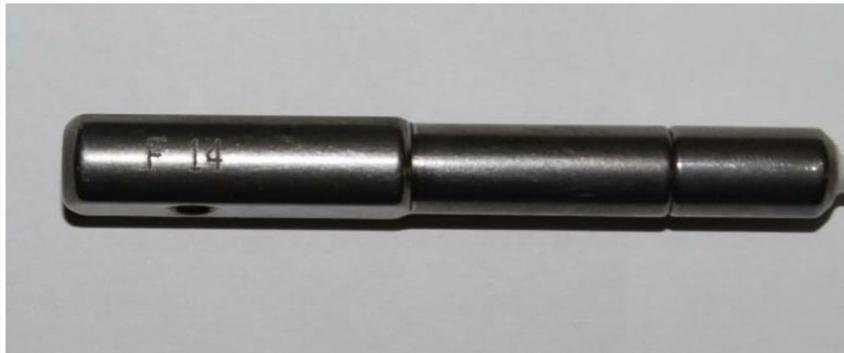
Fig. 4 Series F, year 2014 (marked on cutting unit cable)
