Sicherheitsmitteilung
SM 190301

Betroffene Muster: Firebird EVO

Product Service Bulletin

ISSUE DATE: March 30th 2019
Bulletin Number: FB 2019-01
SUBJECT: Reserve pin ripcord assemblies on Firebird EVO Harness Containers
STATUS: **MANDATORY BEFORE NEXT JUMP**
Affected HC: All Firebird EVO HC with Pillow Ripcord assemblies PN 012 built between April 2018-March 2019, Serial numbers BD 001-CB 010
To: All Firebird Dealers and Customers

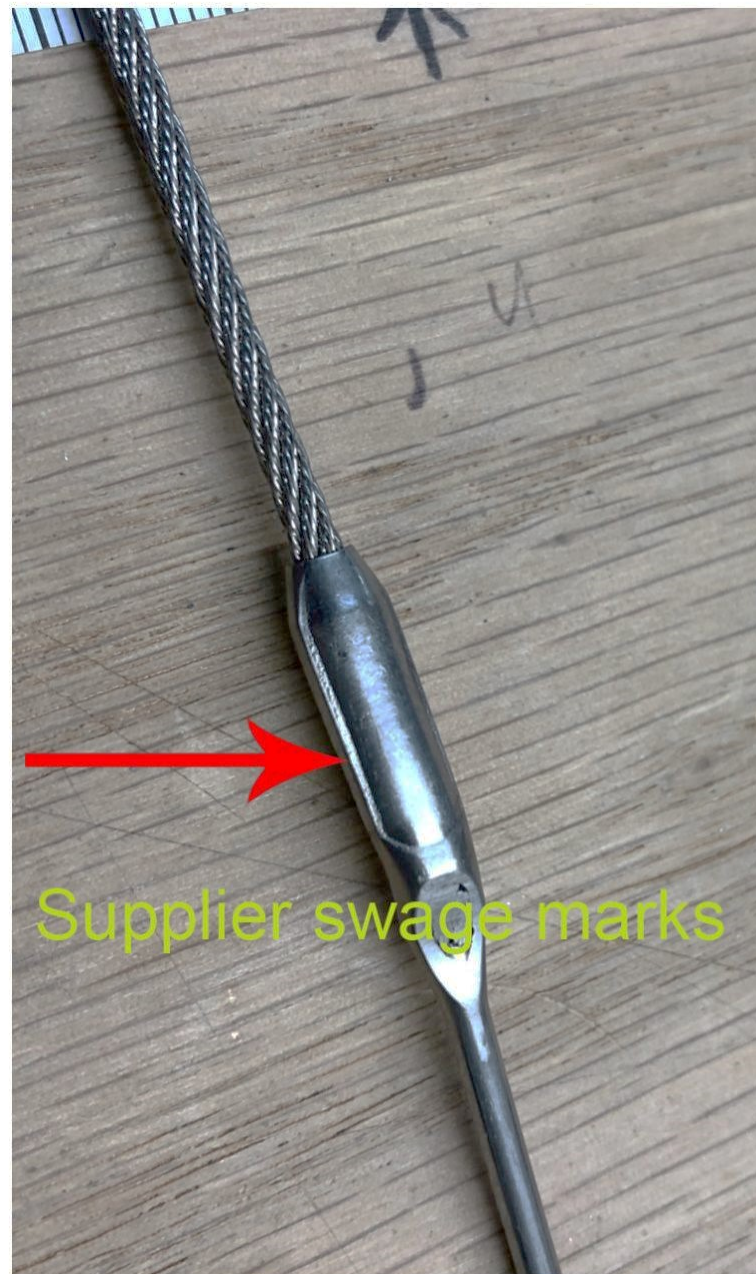
After inspecting the pictures of the reserve cable and pin in question, the supplier and Firebird USA came to the conclusion, that it highly appears that the cable and pin didn't get swaged at all during the manufacturing process which would explain the separation. All other ripcords of that batch of the supplied ripcord assemblies present at Firebird show clear swage marks which makes it easy to confirm if the pin has been swaged. Firebird does occasionally manufacture ripcords using an internal tool and follows a similar test procedure than the supplier. Firebird did test swages with the internal tool which also leaves marks and which will help identifying a "no-swage".

If your HC has a ripcord pillow ripcord assembly installed between SN BD001 and CB010 they have to be visually inspected for swaging marks.

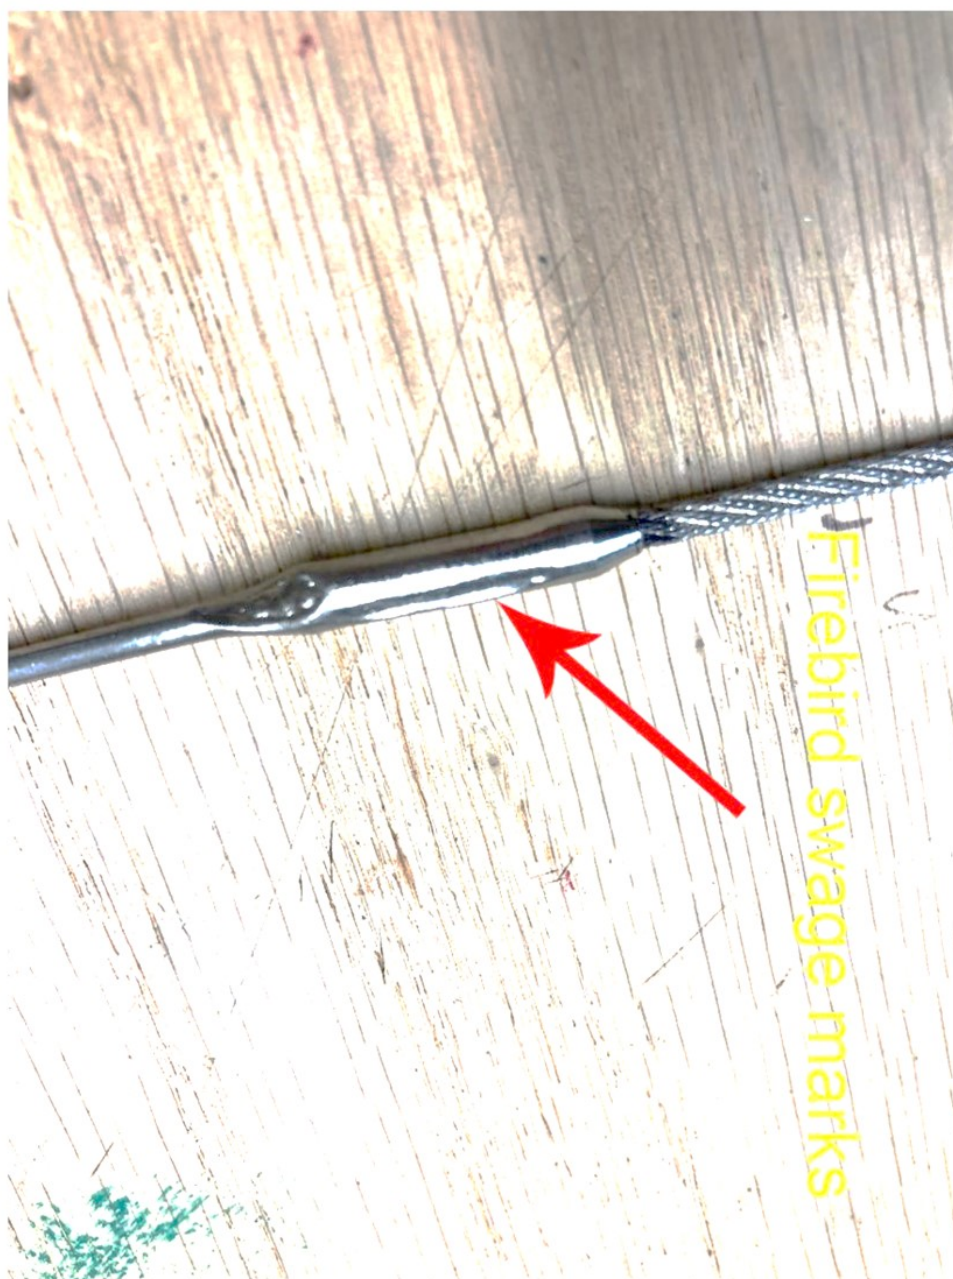
If your reserve pin doesn't have clear swage marks as pictured, DO NOT JUMP until notification and further inspection through Firebird USA LLC.

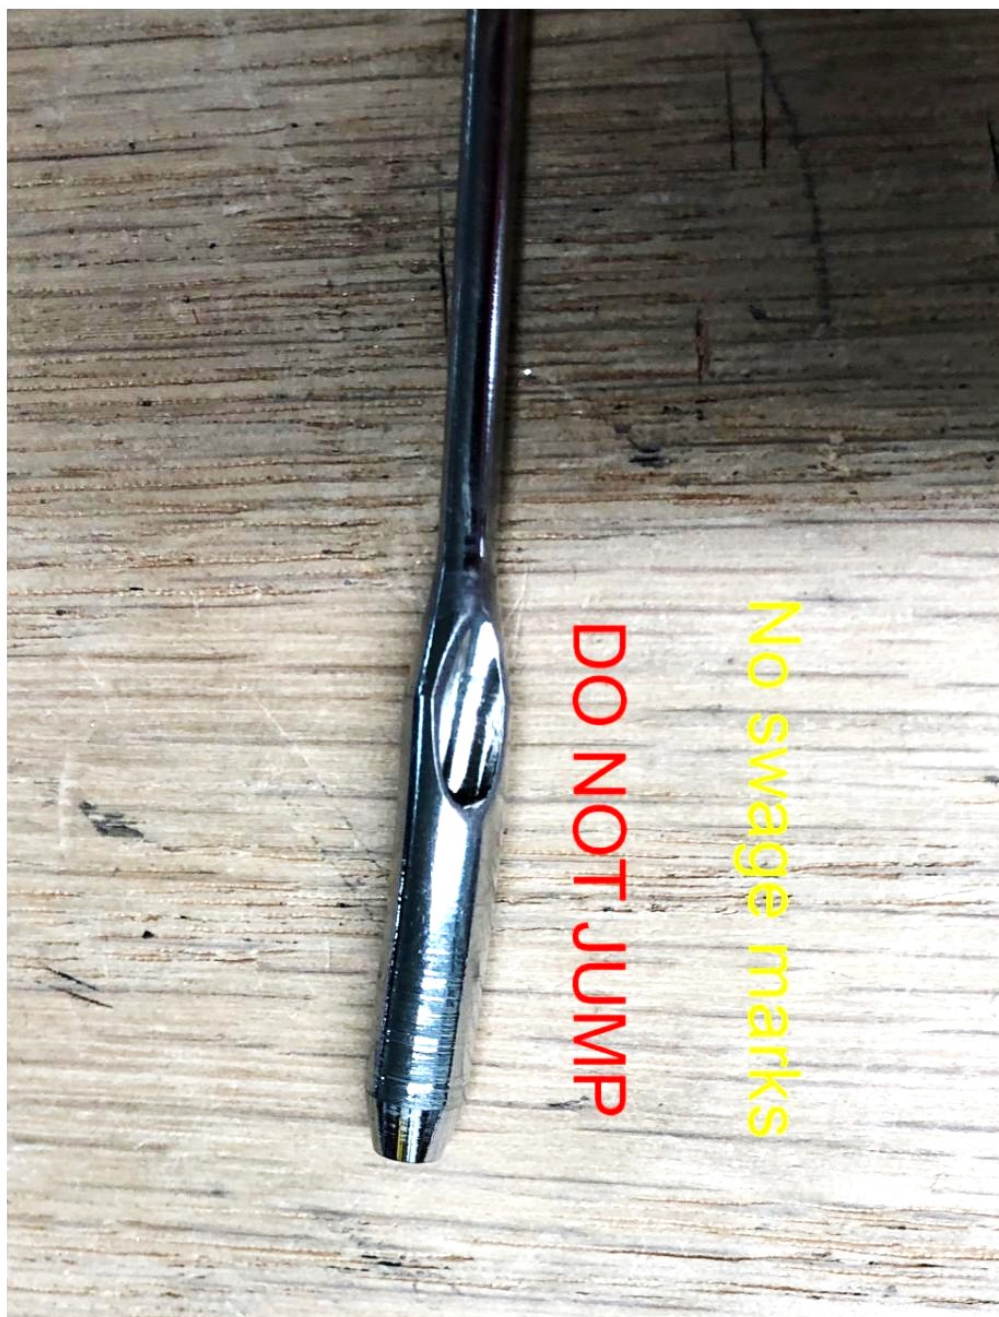
Die nicht zu verwendeten Pinne zeigen wie im Foto des Herstellerbulletins keine Quetschungen der Pressung auf, weshalb sich das Kabel vom Pin lösen kann.

Keine Verpressung! Lebensgefahr! Nicht Springen
