Sicherheitsmitteilung
SM 20230101 – Firebird Evo MLW

PRODUCT SERVICE BULLETIN

Bulletin Number: FB 2021-01

SUBJECT: Firebird V1R1 EVO Harness container systems with adjustable Main Lift Web

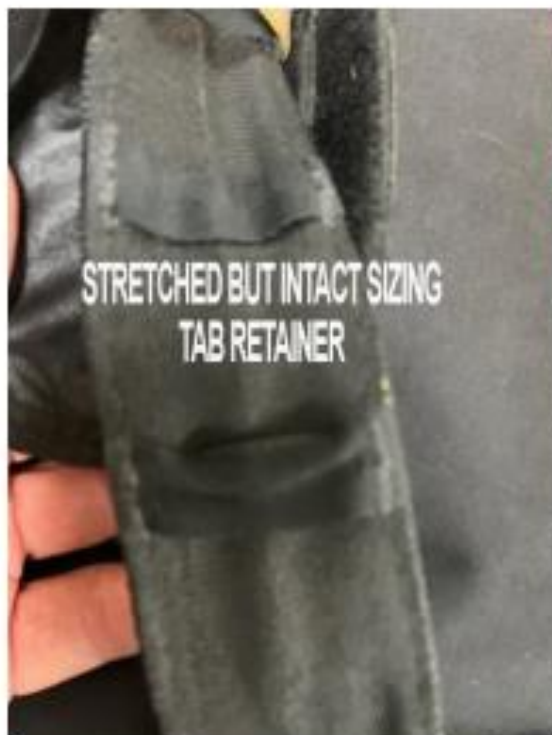
Right Main lift web undone, sizing safety tab ripped off and stuck under a stretched but intact sizing tab retainer (1/2" type 1), 555-2 ring installed **correctly**, **missing** spring, **NO** damage to type 4 stopper.

Stretched tab retainer

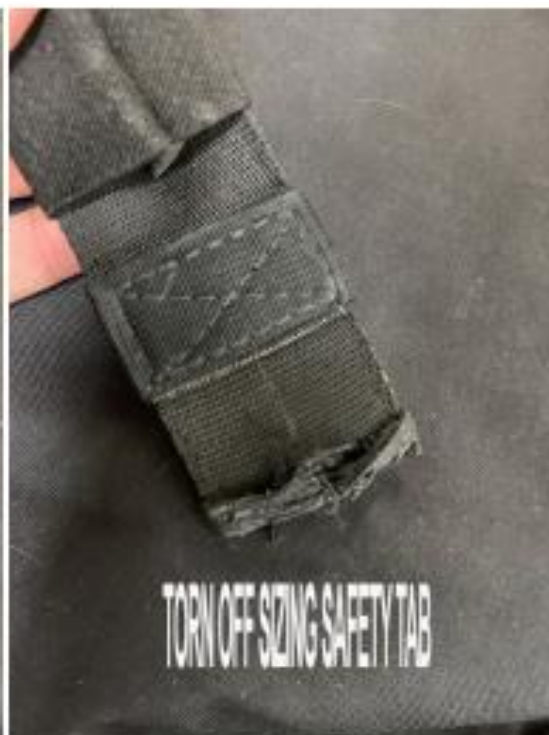
The right main lift web of the affected container that came undone does **not** show any damage on the type 4 stopper with only the sizing safety tab torn off and matches only the findings of at least one configuration of those simulations carried out by Firebird.

Torn off tab, damage free type 4

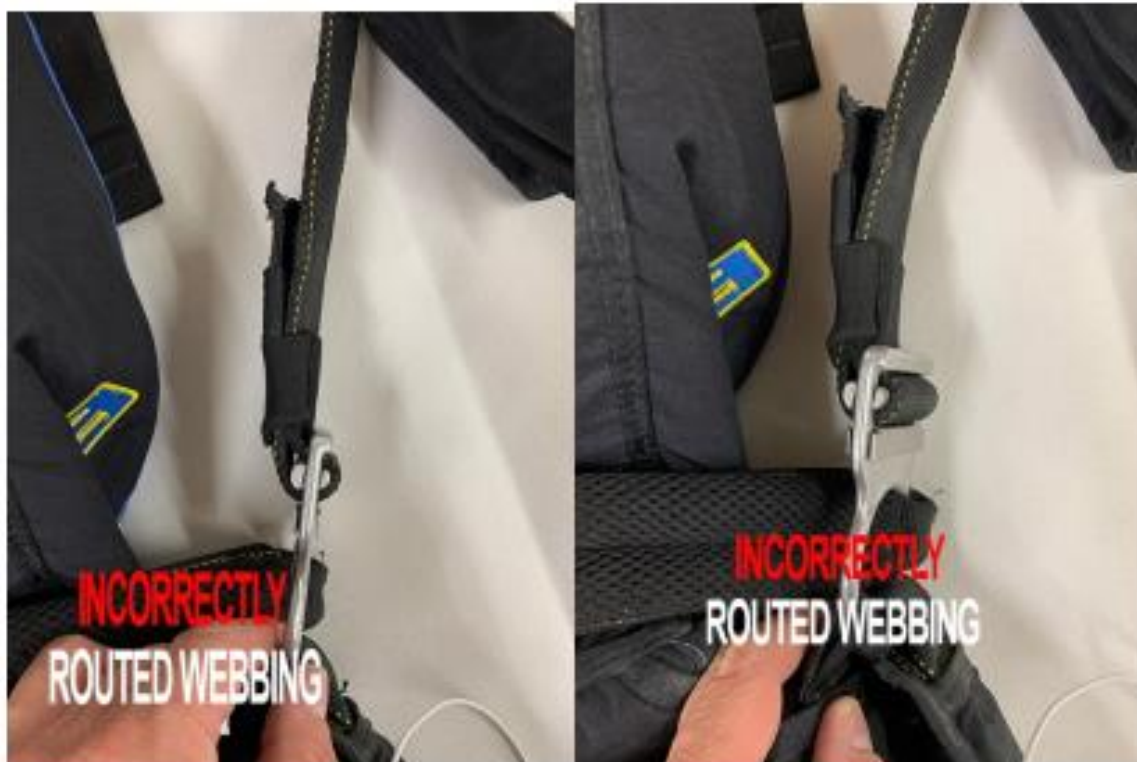
INCORRECT ROUTING PRESENT ON EVO 8611-172

Left Main lift web threaded **incorrectly** (double routing, wrong direction, see pics), sizing safety tab attached with only a few stitches (69tex/E thread) ripped, sizing tab retainer stretched but intact, 552-2 ring installed **correctly**, spring present, **NO** damage to type 4 stopper.

The incorrectly routed webbing on the **left** side strongly indicates that, the **right** side that came undone, most likely also had been routed incorrectly.

Incorrectly routed webbing will result in a slippage towards the open end and in opposite direction of the engineered purpose as the friction lock will not properly engage and not properly block the webbing from slipping.

The configuration of the incorrectly **double** routed configuration as present on the left side of the container, showed a torn off sizing safety tab **and** ripped type 4 stopper in **all** simulations at around 2000 lbs.

Therefore, we mandate a visually inspection before the next jump, to confirm the correct routing of the adjustable main lift web through a type 555-2 ring (DJA/CWH) especially if the container has been disassembled for repairs, maintenance, cleaning, or any other reason. All direct customers have been contacted by Firebird USA LLC.

Always inspect the correct routing of the main lift web before use, especially if the harness-container is in a rental, demo or student setting or was recently in maintenance. To make sure that in the future only qualified Riggers can disassemble the main lift web, we strongly recommend replacing the type 4 stopper with four layers of type 17 webbing and sew a BOX X pattern with at least 5-cord. Firebird USA LLC uses exclusively 6-cord.

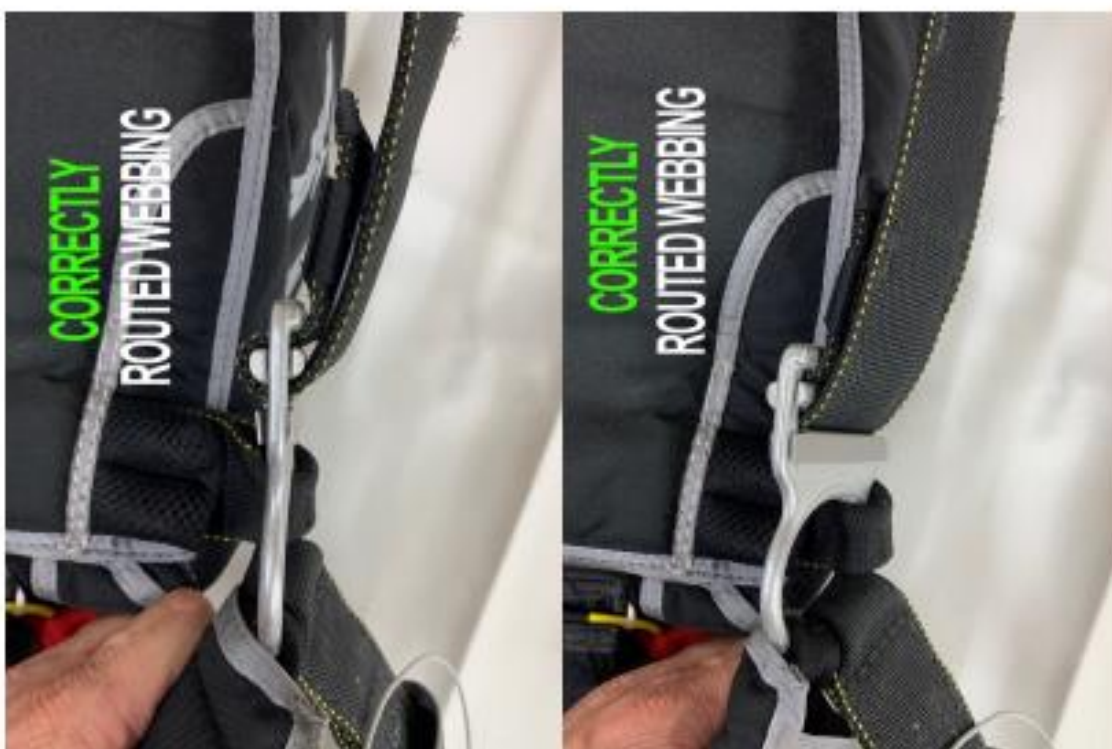
!!!! CORRECT ROUTING !!!!

Correctly routed webbing, **regardless** of the ring direction, showed **zero** slippage or damage.
