ÖSTERREICHISCHER AERO-CLUB

Sicherheitsmitteilung 040301 Erweiterung von Sicherheitsmitteilung 030702

Betrifft: Griffe und Pinne (Ripcord-Pin)

Manufacturer Product Service Bulletin Number CW03-01

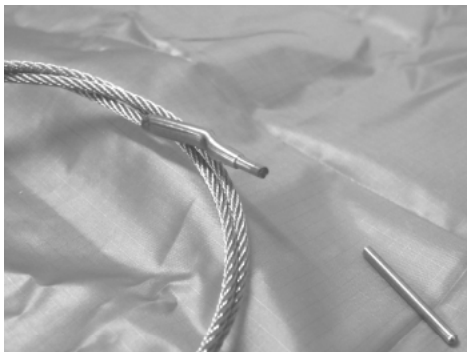
Hintergrund: Es wurden in letzter Zeit Pinne entdeckt, die nicht in den von Capewell angegebenen Zeitraum vielen und trotzdem gebrochen sind, oder sich verbogen haben.

a) gebrochener Pin

Maßnahmen: Das Testen nach Anweisung. (siehe Beilage).
aller Pinne ohne Testkennzeichen am Griff.

Nach erfolgreicher Beendigung des Tests, muss der Griff vom Ripcord mit CW03-01 gekennzeichnet werden. Pinne müssen nach dem Test auf Deformationen inspiziert werden.

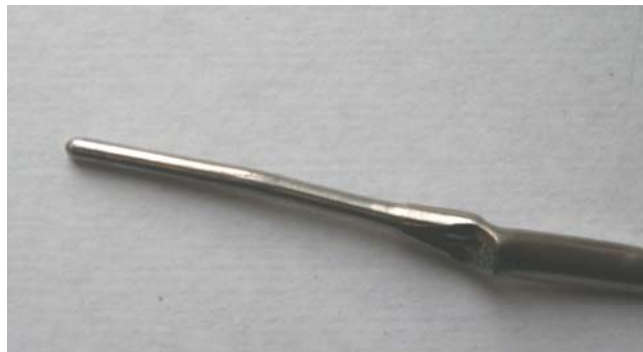
b) verbogen, Oberflächenrisse!

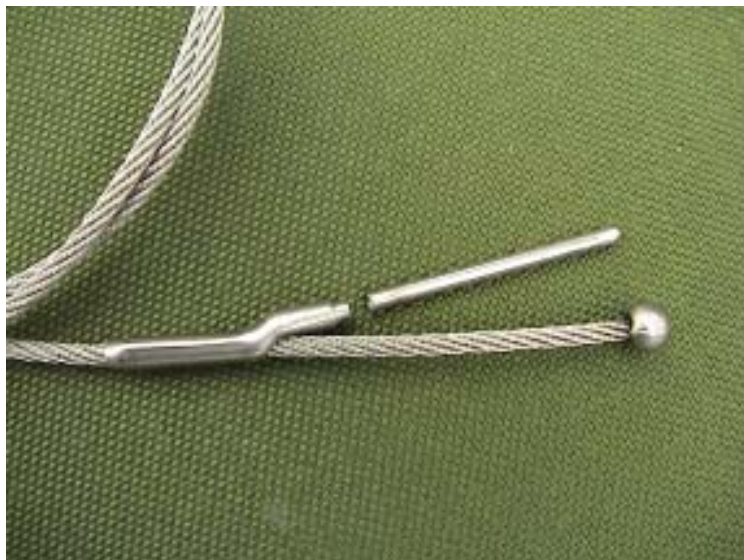
Capewell Components LLC has received (3) reports from (3) customers of (4) ripcord pins that broke. All (4) pins were reported to have broken under very low force. All (4) pins are reported to have broken on the blade section of the pin, approximately 1/8" (3 mm) from the shoulder of the pin. A broken pin is pictured below.

Broken Ripcord Pin

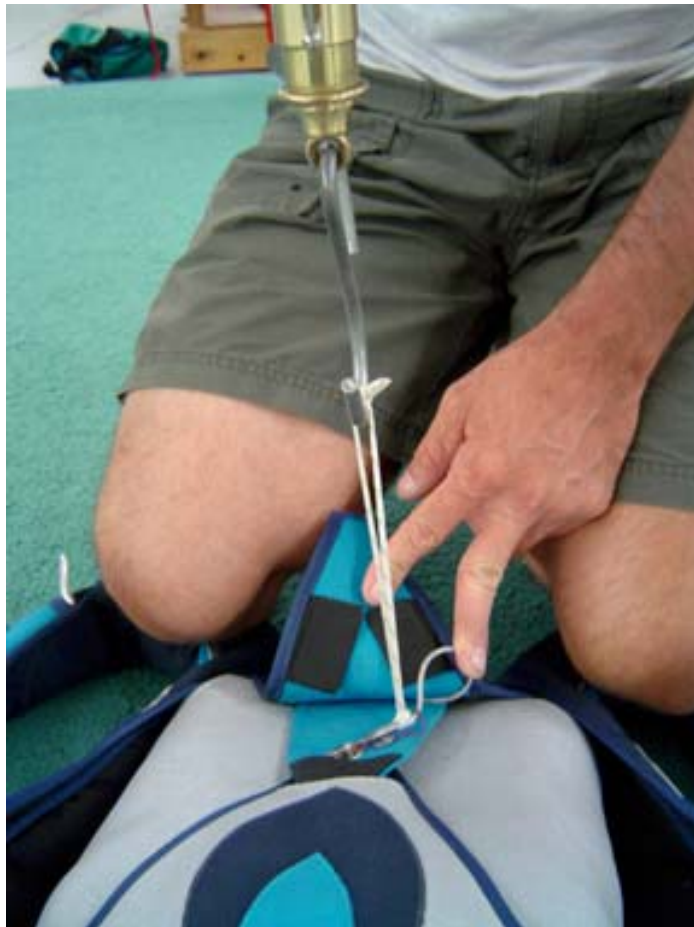
FIGURE 2

5. Secure the other end of the loop to the spring scale.
6. Apply a load of 15 lbs. (6.8kg) straight up and 90 degrees to the axis of the pin for a period of 3 seconds and then release the load (Fig. 2). Inspect the pin for any deformation or bend. If the pin is straight, continue with step 7 below. If the pin is not straight, as visible without magnification, remove the pin/ripcord from service immediately.
