Service Bulletin

Issue Date: 25 June 2009

Subject: Service Bulletin for Icon S7, S8 and S9 Student rigs

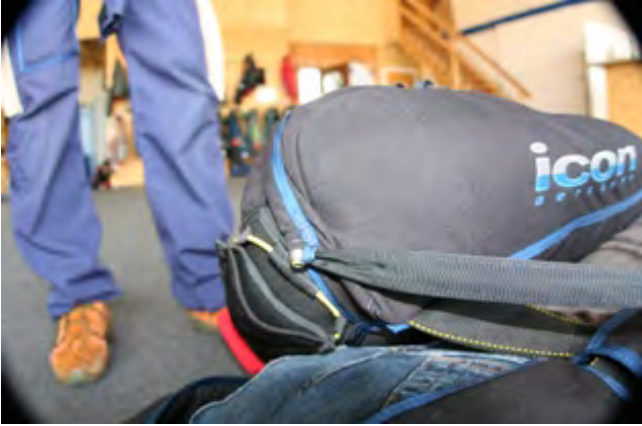
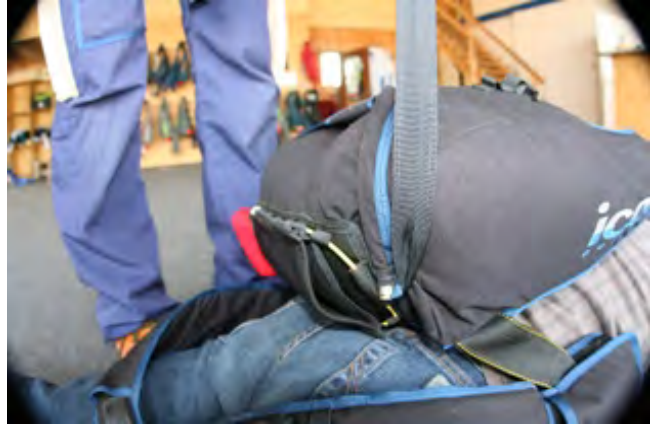
On deployment, it is possible for the bridle to catch on the housing.
