ÖSTERREICHISCHER AERO-CLUB

Sicherheitsmitteilung 040902

Herstellerbulletin: N°04/002 von 23/08/04

Betrifft: Umlenkklappe (Deflector flap)

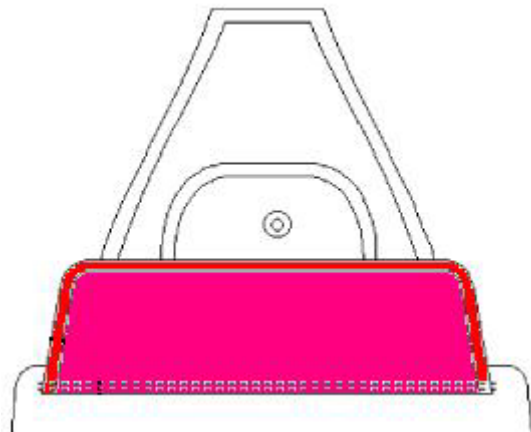
Problem: Durch Verformung der Versteifungsplatte in der Umlenkklappe wird die Funktion von dieser Klappe verringert.
Diese Klappe ist dazu da um eine Mögliche Behinderung und Funktionsbeeinträchtigung durch eine oder mehrere Fangleinen der Hauptkappe mit der Verschlussklappe (Nr.4) des Hauptschirm-Containers zu verhindern

Maßnahmen: Bei allen betroffenen Systemen muss vor dem nächsten Sprung die Umlenkklappe auf Verformungen kontrolliert werden.
Sind Verformungen sichtbar, (im Herstellerbulletin: **case N°1**)

muss das System sofort vor dem nächsten Sprung nach Herstellerrichtlinien genäht werden.

Sind keine Verformungen sichtbar (im Herstellerbulletin: **case N°2**) muss das System beim nächsten Reserve-Repack nach Herstellerrichtlinien genäht werden.
