ÖSTERREICHISCHER AERO-CLUB

Sicherheitsmitteilung

060102

Änderungen Packanweisung

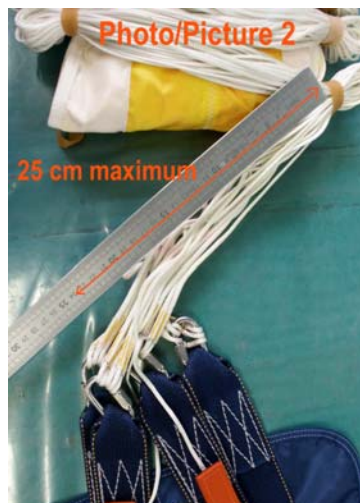
The damages are due to one or more overlines causing the damage of several panels. It is likely that this incident is due to one or more lines passing over the diaper during the extraction of the container.

- To replace the current rubberbands by **mini rubberbands optima P/N 2015000600** (Cf picture 2).
- To use an additional mini rubberband optima on attachment tapes number 11 (diaper line) in order to add an additional stow at the beginning of the stowage (Cf picture 1).
