## ÖSTERREICHISCHER AERO-CLUB

### Sicherheitsmitteilung

SM 060401

**Betrifft:** Beschädigungen an der Plastikhülse des Cutters und am Loop

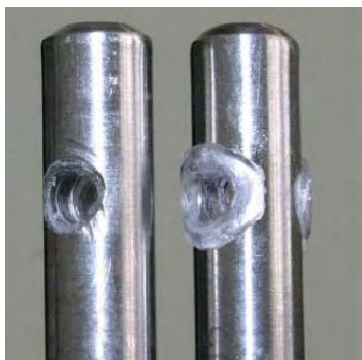
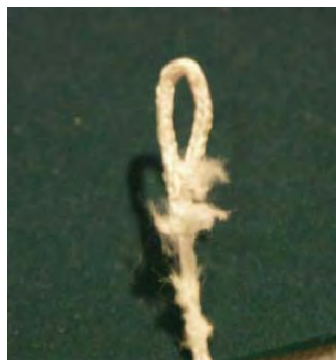
**Grund:** Beschädigungen durch unsachgemäßes packen und Benutzung von „Kraftaufwand – reduzierende -Werkzeuge“:  
Anlage SB #2-pictures\_photos : Bilder #1 , #2 , #3

**Maßnahme:** Es ist besonders darauf zu achten, dass die Kunststoffhülse des Cutters während des Reservepackens nicht beschädigt wird.  
Sobald irgendeine Beschädigung der Kunststoffhülse erkennbar ist, ist es unbedingt notwendig, den Cutter und den Loop zu ersetzen.
