ÖSTERREICHISCHER AERO-CLUB

Sicherheitsmitteilung

SM160101-2

SUBJECT: DSF Stainless Steel Hardware on Vortex Harness Containers

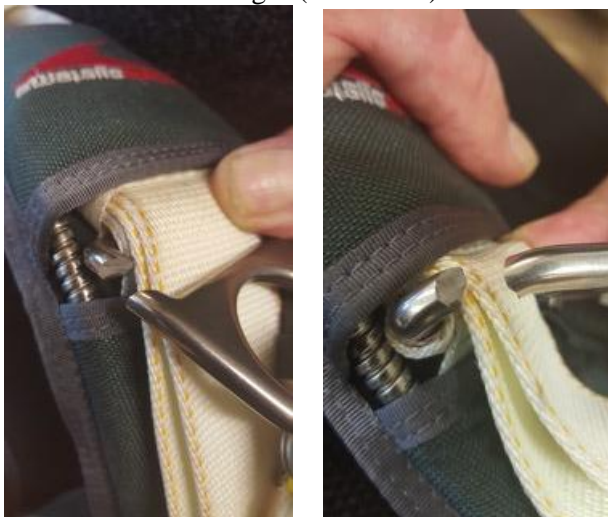
Alle Vortex Gurtzeuge mit einem Mini-3-Ringsystem aus Edelstahl bei dem das Logo „DSF“ auf dem Base-Ring (Schlitzring) des 3-Ringsystems und/oder auf Brust-/Hüft Schlitzringen (wenn vorhanden) eingepreßt ist/sind.

Grund: Bruch eines Ringes (siehe Foto)

Die betroffenen Systeme gemäß PSB 2016-01 einschicken

- Registrieren mit Anhang 2 (Replacement Form) an vortexrecall@parachutesystems.com
- „Letter of Autorization Request“ anfordern, wenn bereit zum Versand (Betreffzeile soll Name und Seriennummer enthalten)
- Beachte: Gurtzeug ohne Reserve, Hauptschirm und Öffnungsautomat einschicken! Dabei sein muss : **RSL (falls vorhanden) , Haupttragegurte bei RSL Reserve Freebag, Reserve Griffe/Handles und Trenngriffe!**
