Sicherheitsmitteilung  
SM171001

**Betroffene Muster:** SIFE Hauptschirmtragegurte

## Service Bulletin 2017-002

Subject: Ring position on SIFE main risers

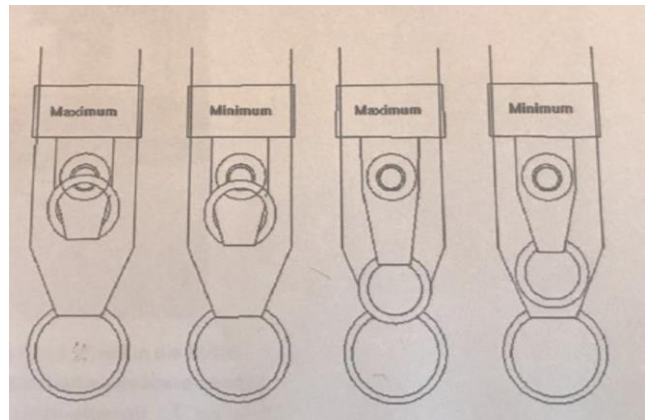
**Grund:** Meldung, dass bei einem Release Funktionstest am Haupttragegurt, die Funktion erst nach händischem Lösen der 3-Ringe gegeben war. Die Herstelleruntersuchung ergab, dass der betroffene Haupttragegurt nicht den Herstellerspezifikationen entsprach

1. Kontrolliere ob die Haupttragegurte, den auf der Abbildung gezeigten Toleranzen entspricht:
2. Sollten die Tragegurte nicht der Herstellerspezifikation entsprechen, oder sollten Unklarheiten auftreten, ist der Hersteller unter: [office@sife.at](mailto:office@sife.at) zu kontaktieren.  
Betroffene Haupttragegurte werden durch den Hersteller kostenfrei ersetzt.

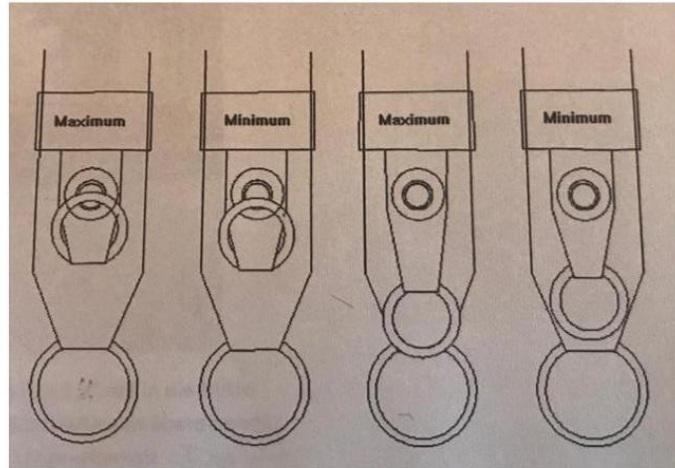
We have been informed that during the simulation of a cutaway procedure, the 3-ring-system released only after a short tug on the risers. The result of our investigations is that the position of the small ring on the affected main risers may not meet the design specifications.

1. Check the ring position on your main risers with the following figure:

2. If your main risers do not meet the design specifications, or if you are unsure please send us an e-mail to [office@sife.at](mailto:office@sife.at).

The main riser replacement will be free of charge.
